BRIDGE ENGINEERING MEETS FOOTBALL

[SAFETY AND REHABILITATION OF EXISTING STADIUM STRUCTURES]

Dansk Ståldag
November 14, 2024

Monitoring & Analyses of Existing Structures
Ramboll Denmark

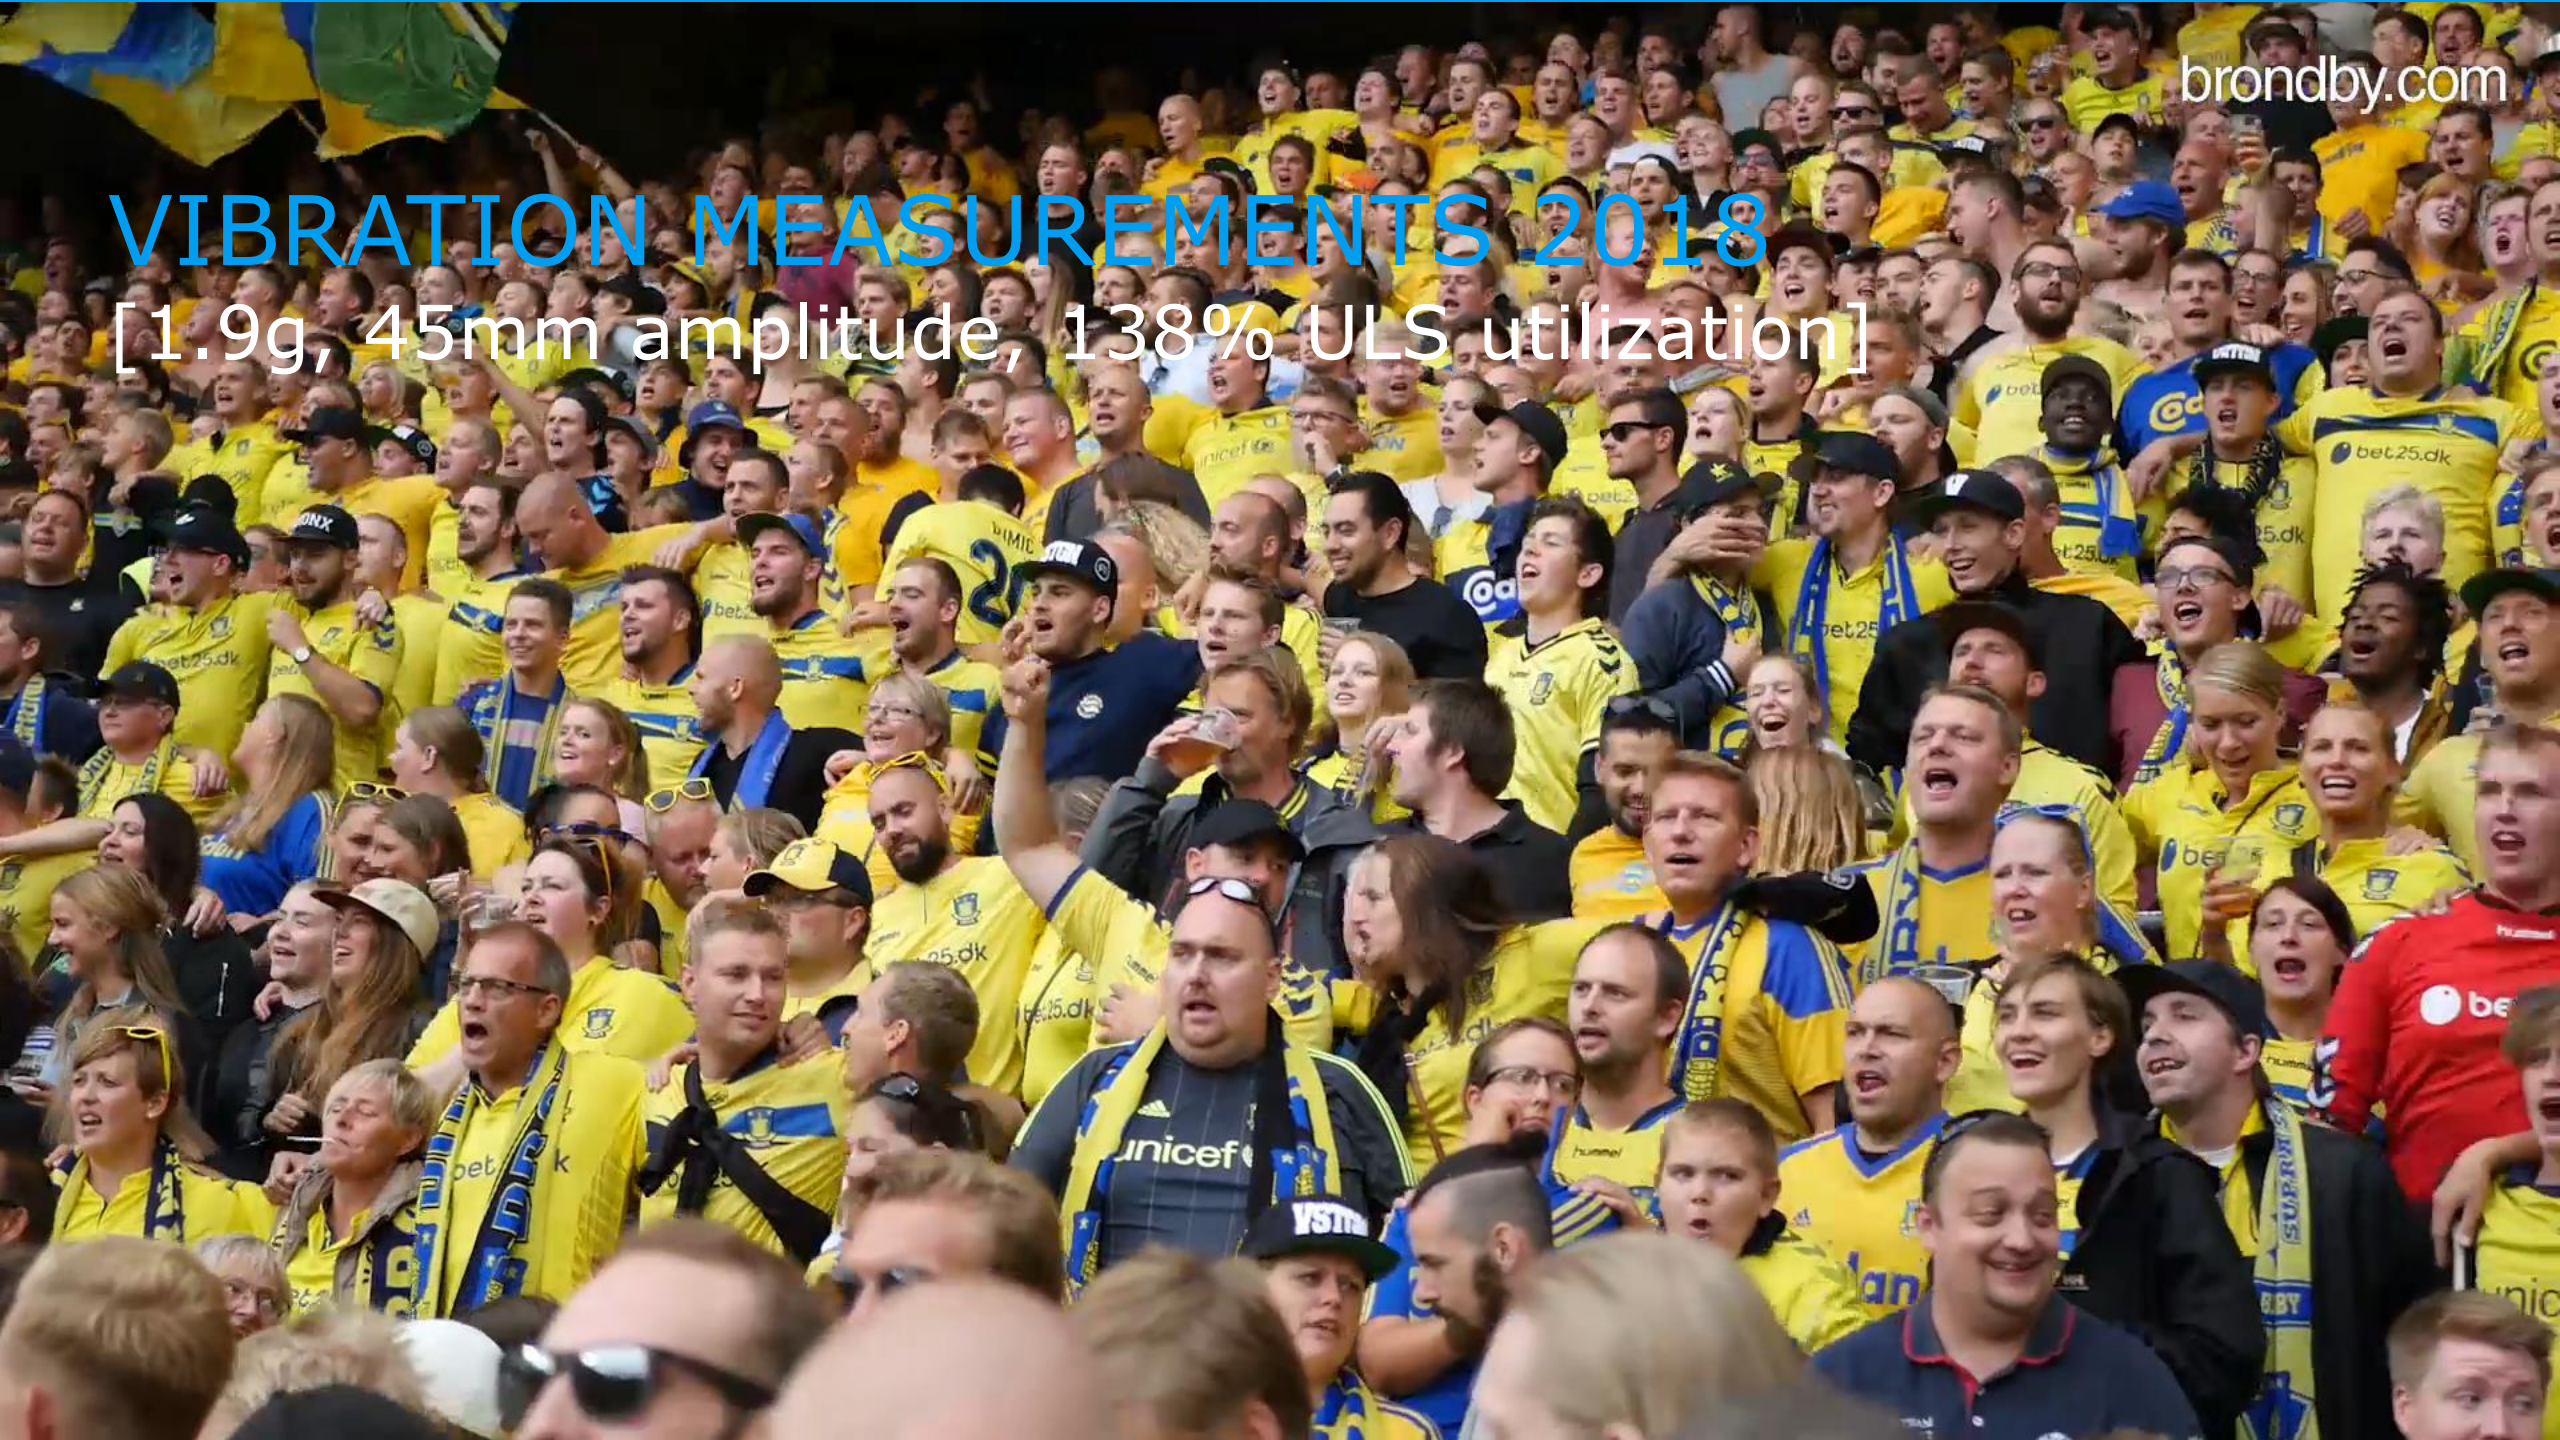
VIBRATION MEASUREMENTS 2018

[HIGH SLENDERS - LENGTH 14 M 1ST NATURAL FREQUENCY 5,4 HZ]

[1.9g, 45mm amplitude, 138% ULS utilization]

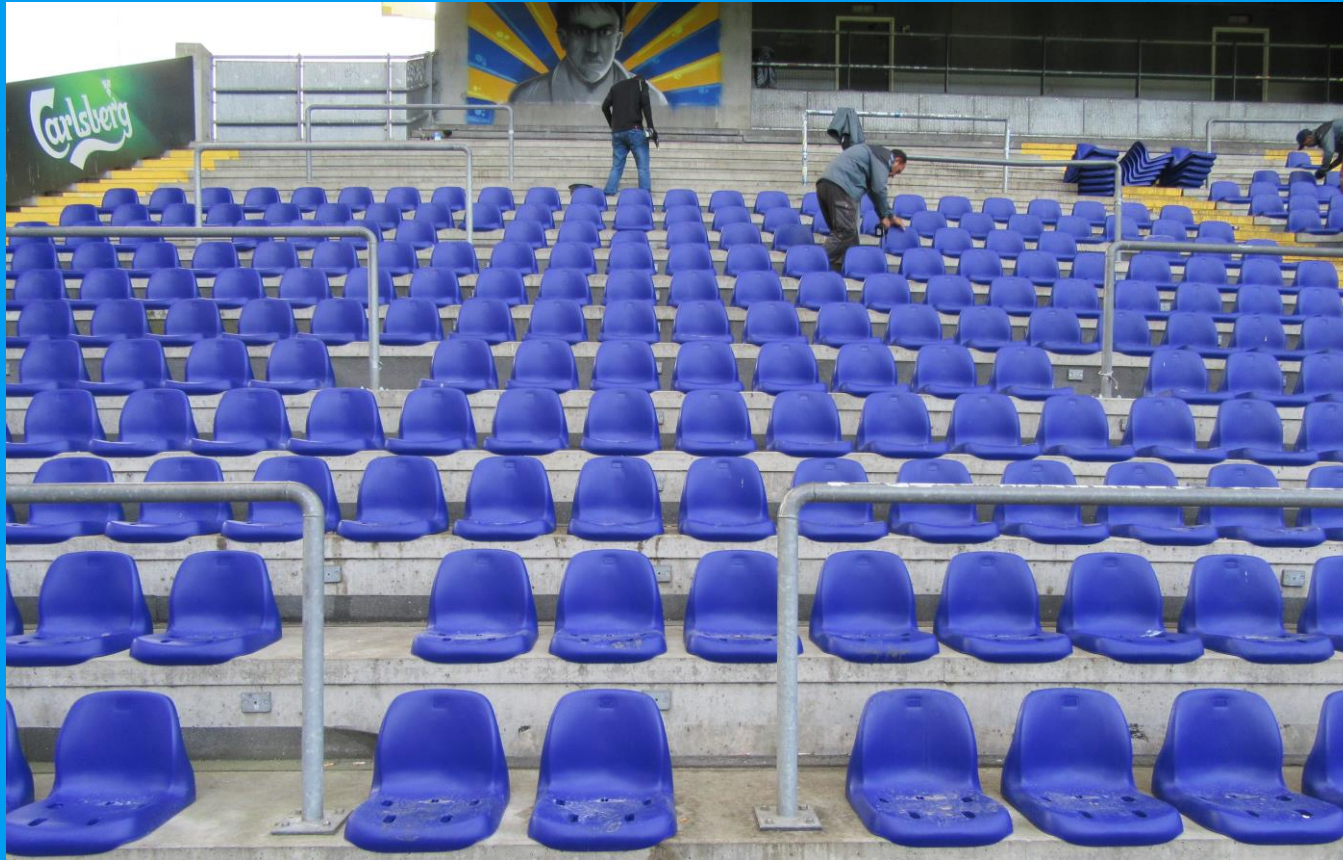
SAFETY ASSESSMENT

[cause of immediate restrictions]

>INSTALL CHAIRS

Reduce static load
Limit jumping

>CLOSE CENTRAL SECTIONS

Historical high loading
Disperse dedicated fans

>REDUCE CAPACITY

From 4700p to 2750p

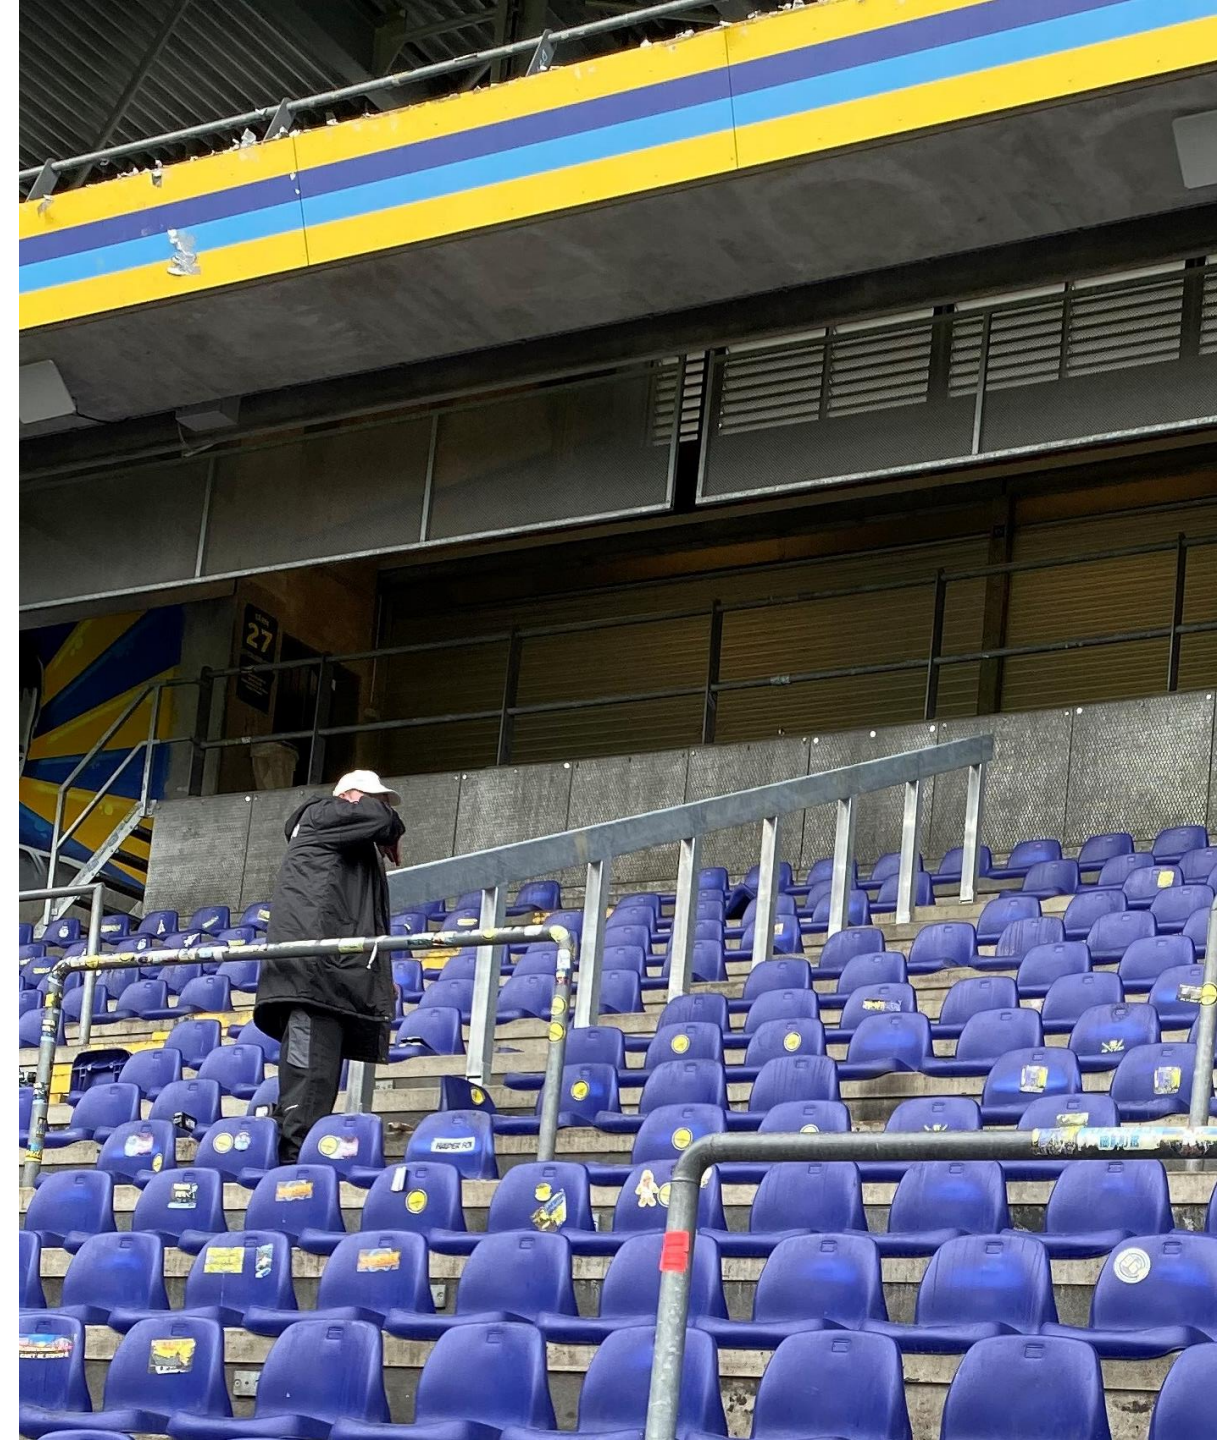
REHABILITATION BASED ON MEASUREMENTS

- > Strengthening solution guided by measurements – magnitude, correlations, variations, outliers
- > Connection of terrace elements by cross bracings
- > Validation by monitoring before-and-after

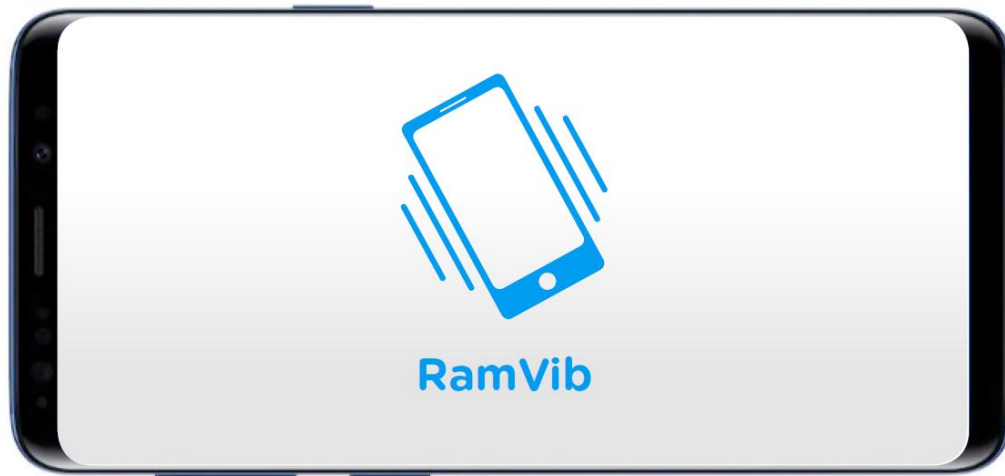
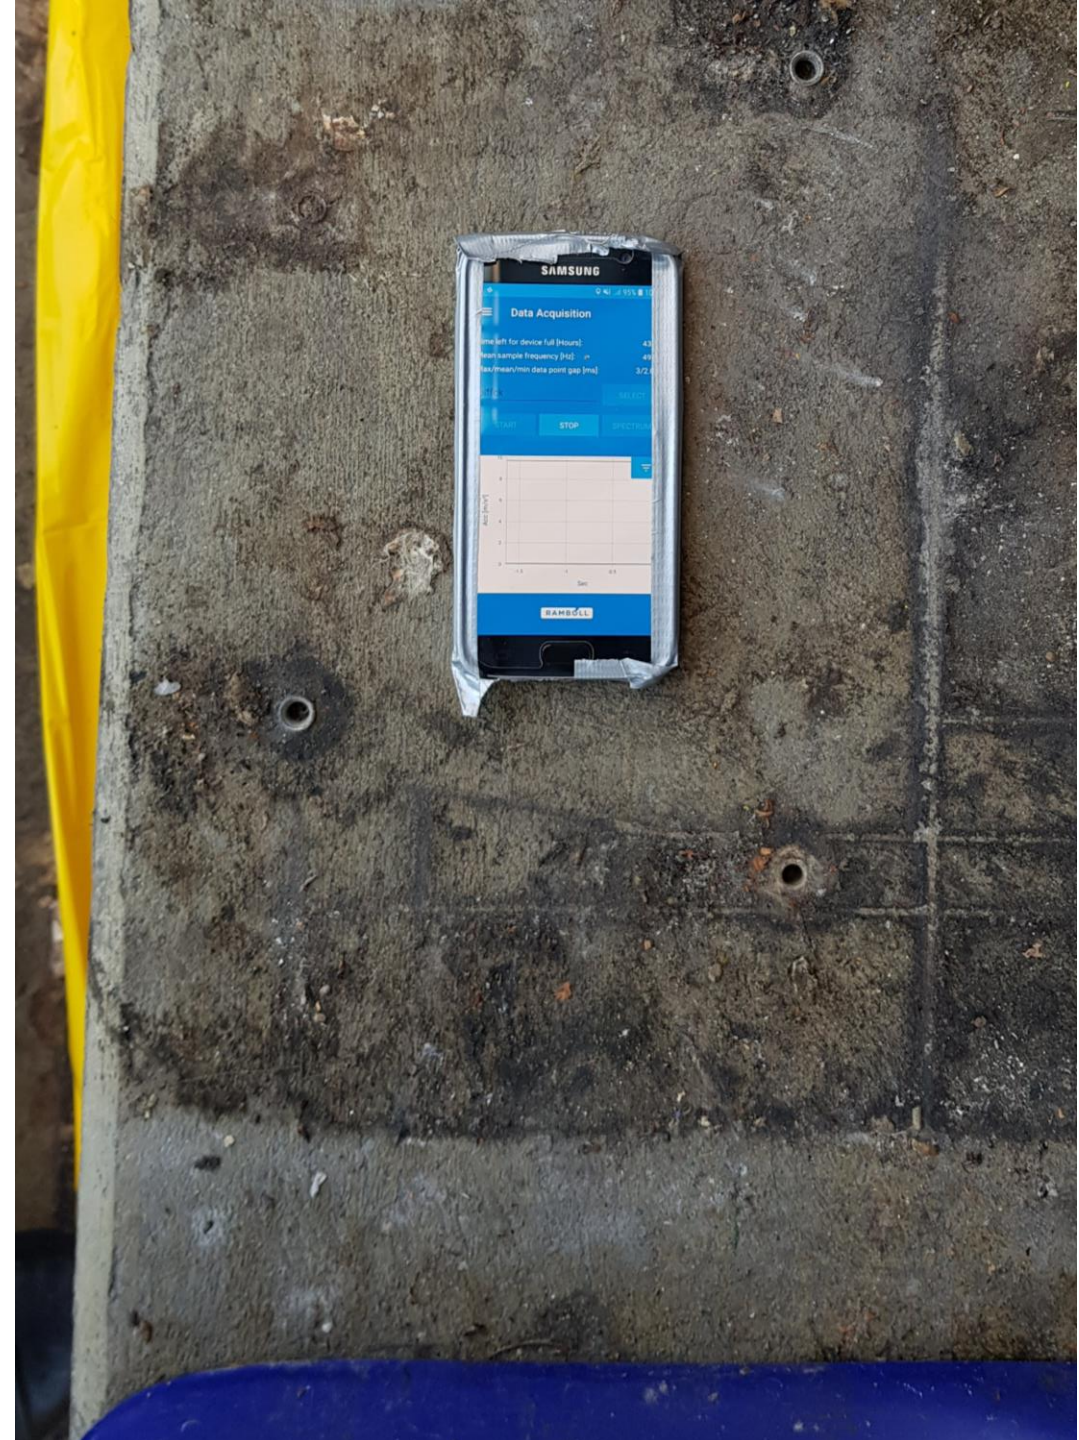
SMART PHONE MONITORING

[Cost effective]

- > Permanent monitoring of vibrations for continuous safety
- > Cost-effective monitoring system with RamVib smartphones
- > Remote online access, automatic cloud upload and analysis

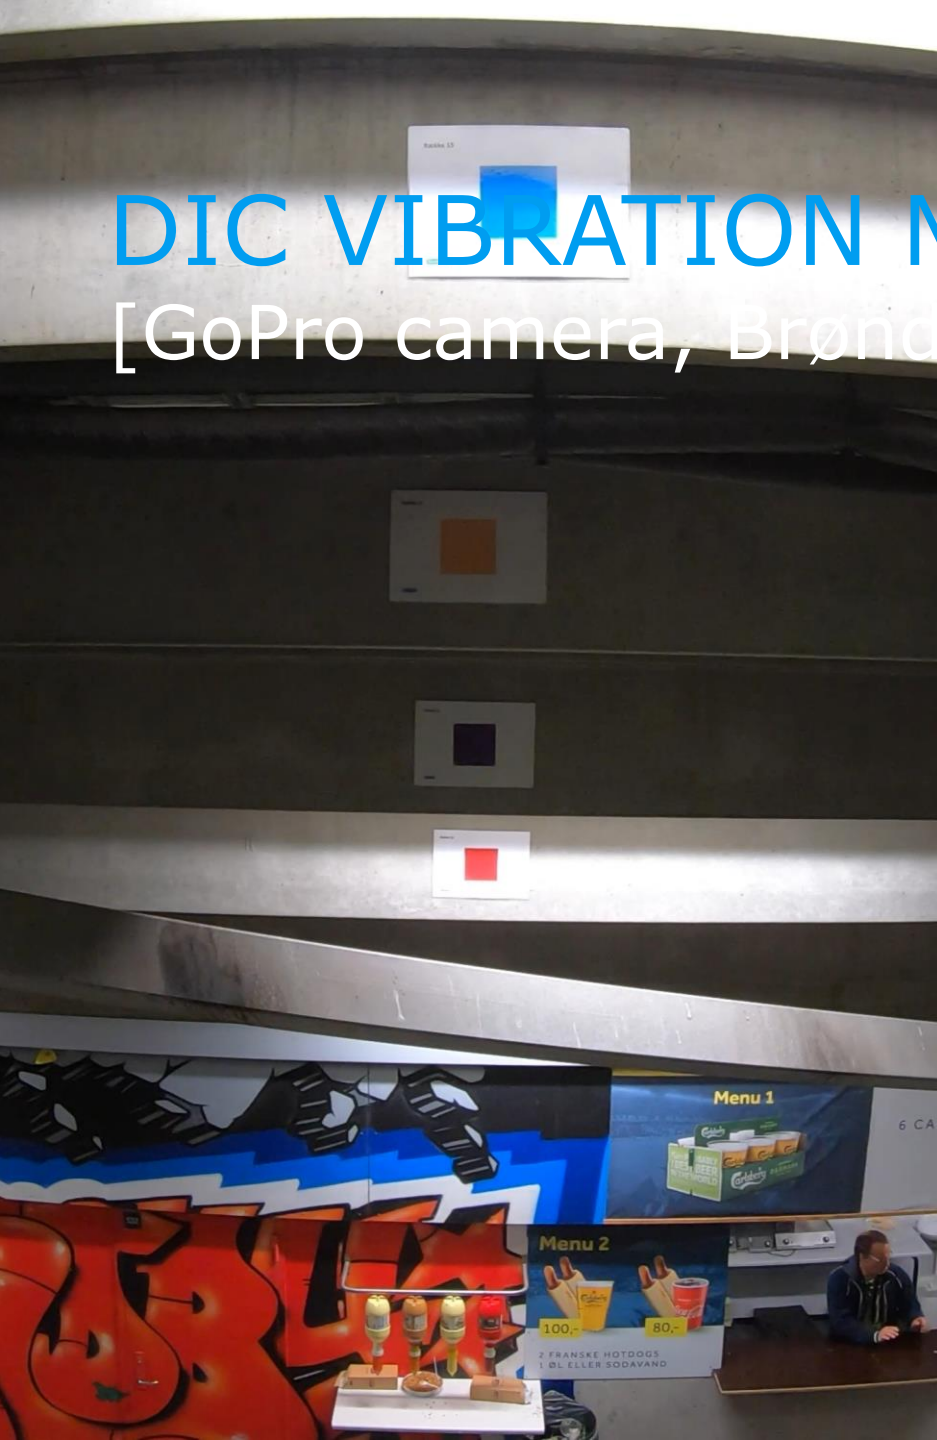
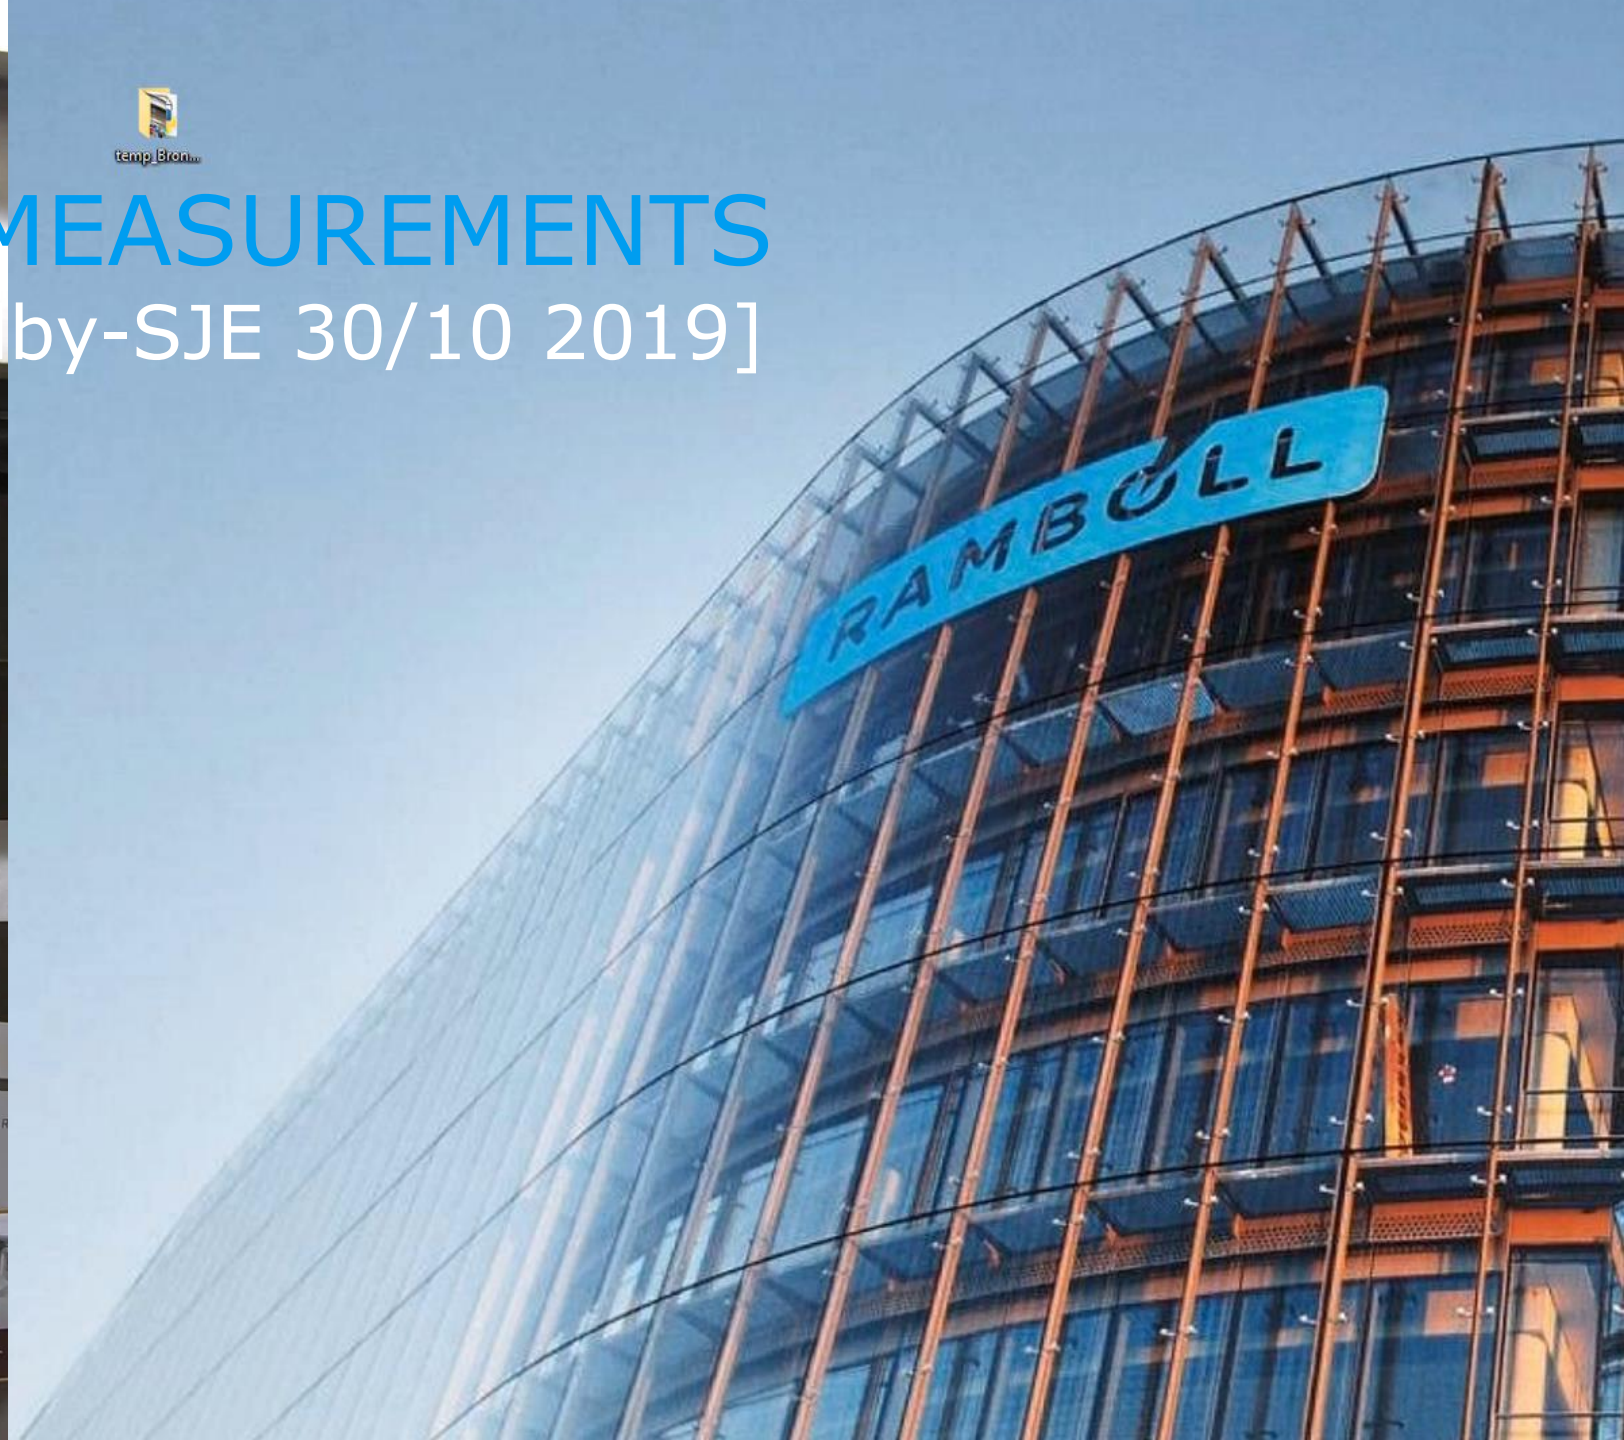
DIC VIBRATION MEASUREMENTS

[GoPro camera, Brøndby-SJE 30/10 2019]

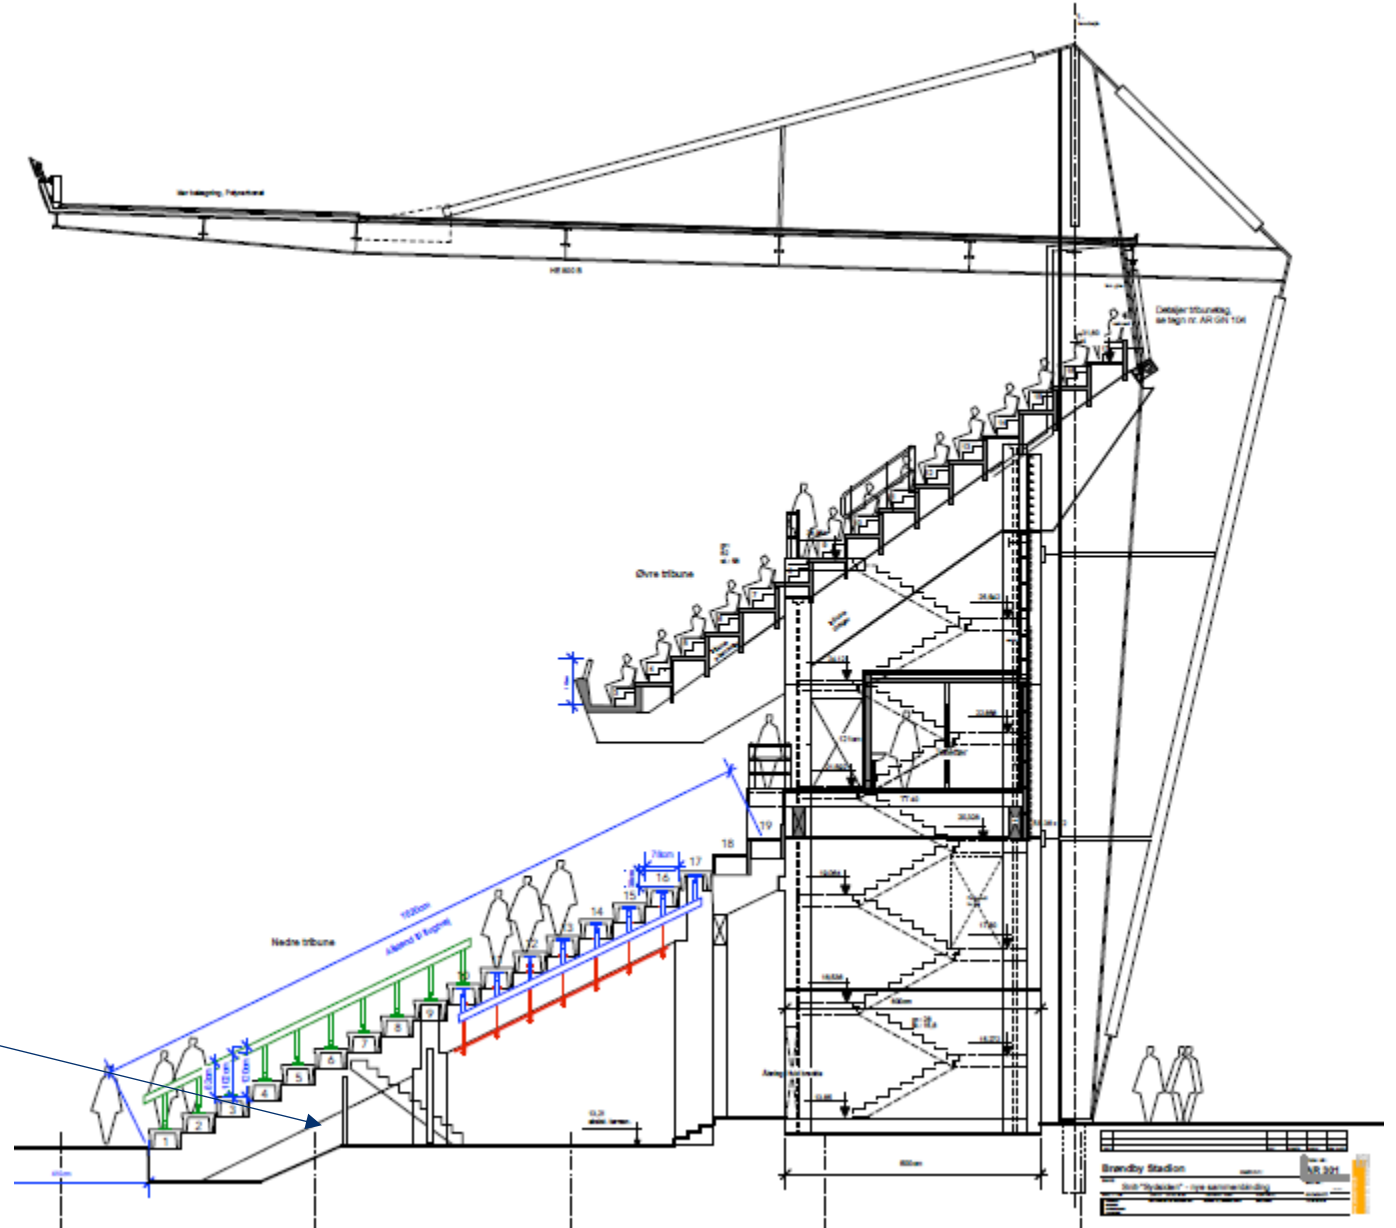
NEW STEEL STRUCTURES

**TRANSVERSE STIFFENER
BELOW DECK, ROW 10-17**

**TRANSVERSE STIFFENERS
PARAPHETS, ROW 1-10**

**MAIN GIRDER REINFORCEMENT
UPPER, ROW 9-17**

**MAIN GIRDER SUPPORT
LOWER, ROW 1-9**

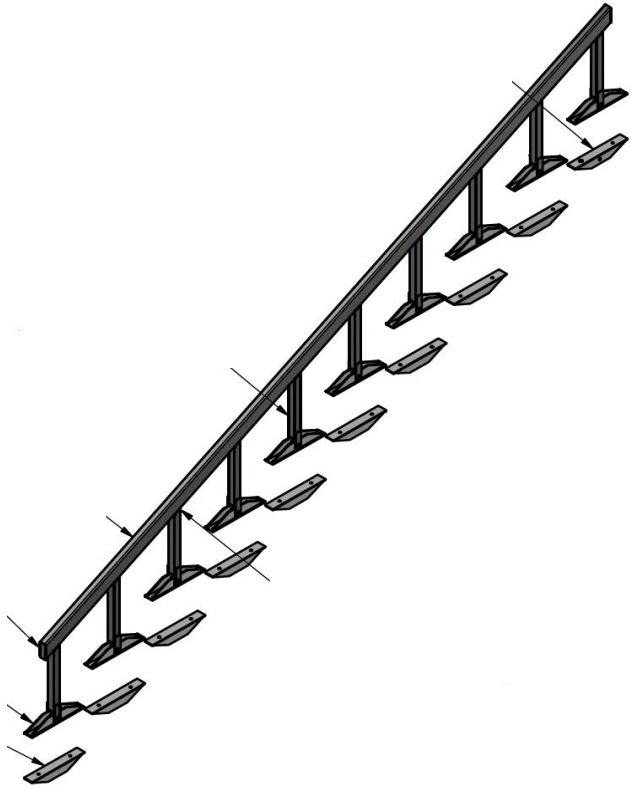
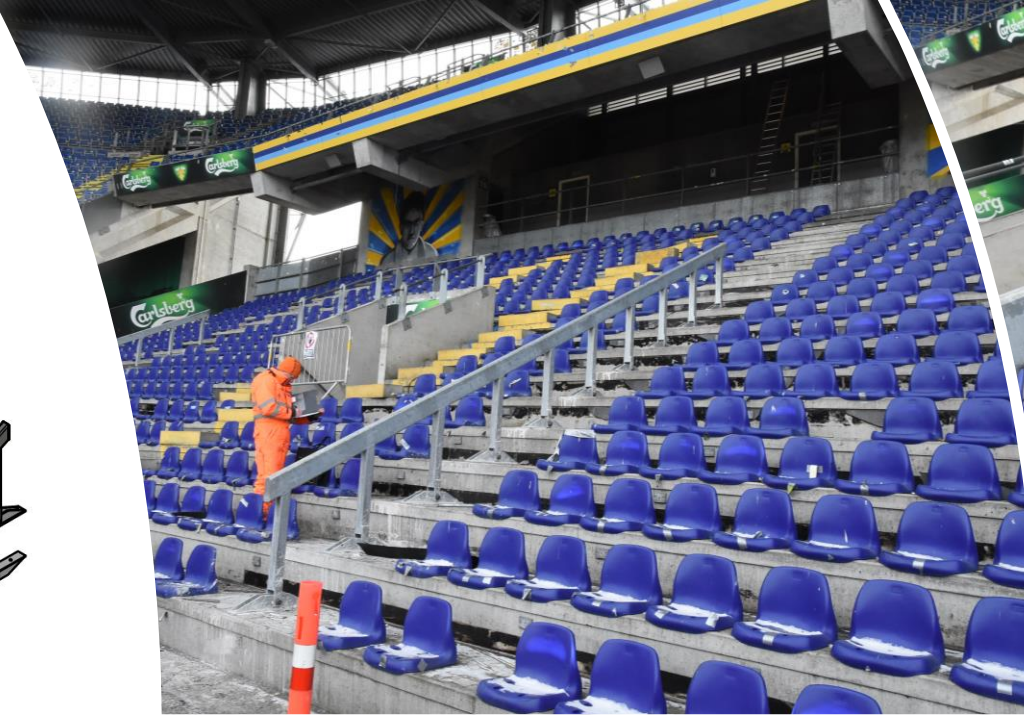
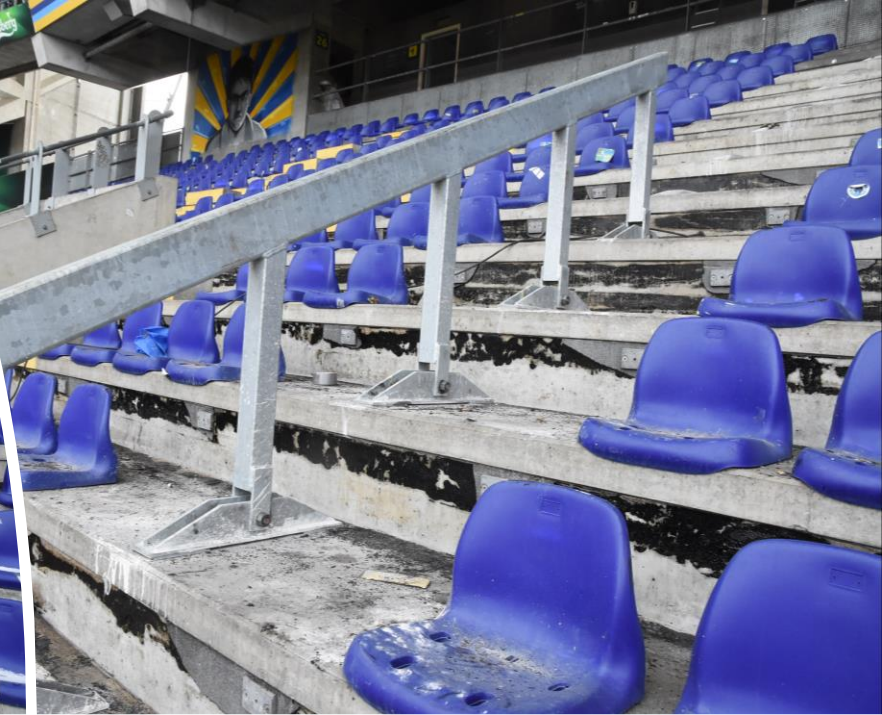
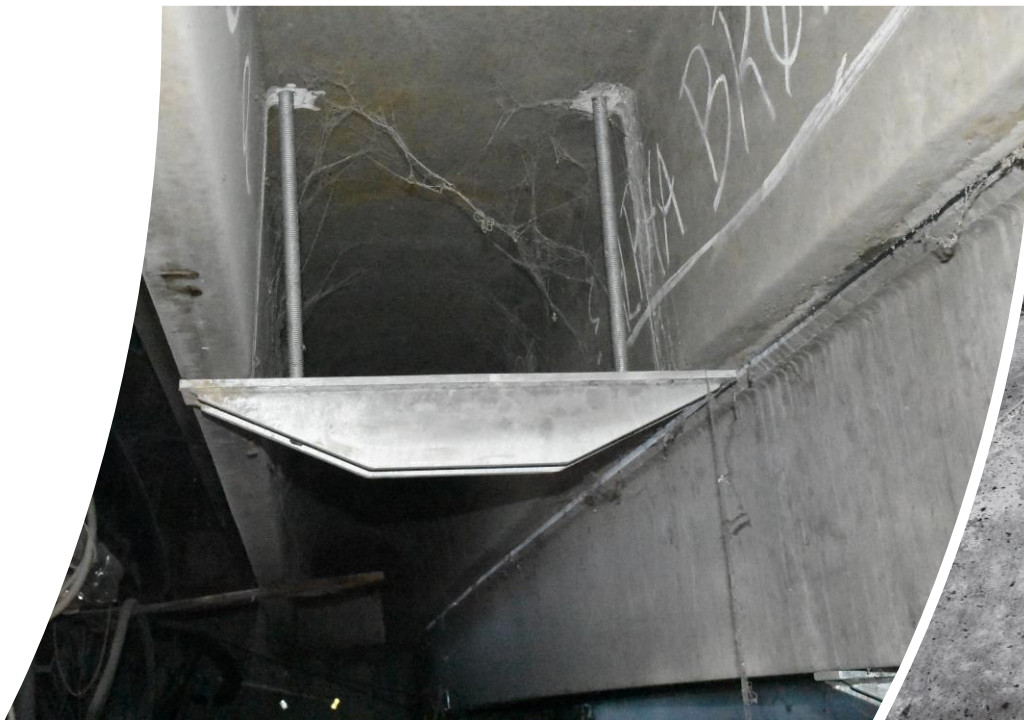
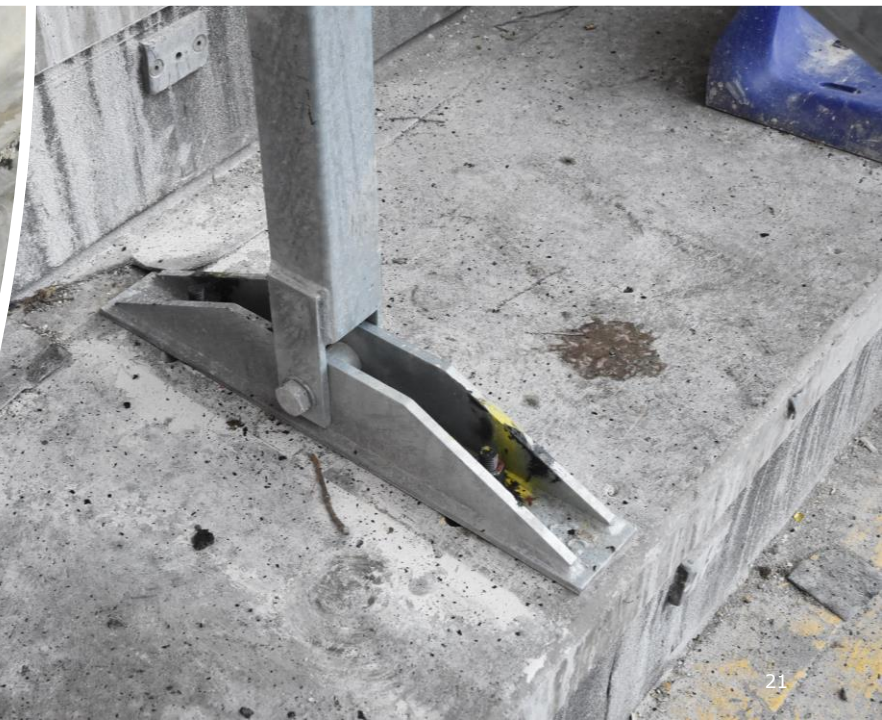
Transverse beams upper parapehets row 1-9

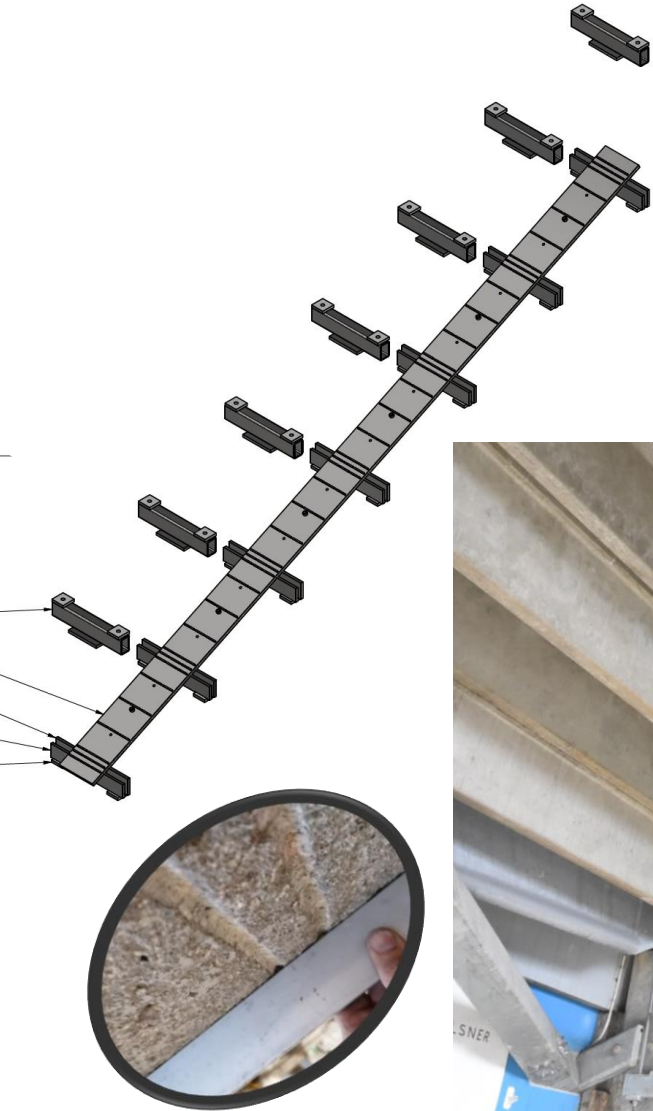
Reinforcement of upper main girders (row 9-17)

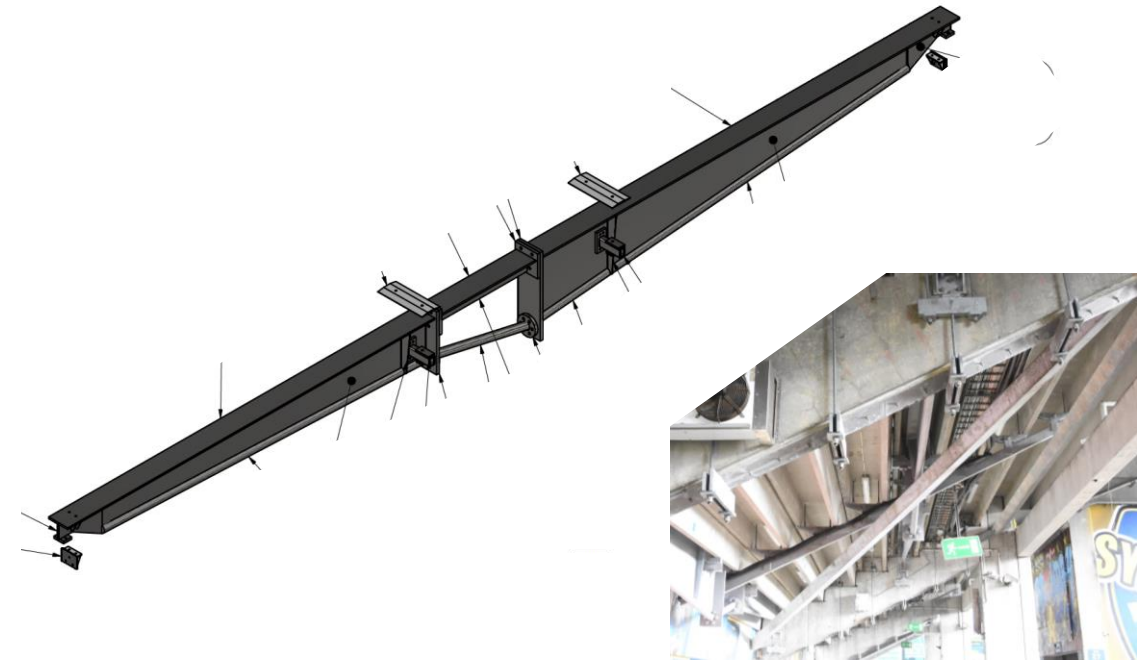
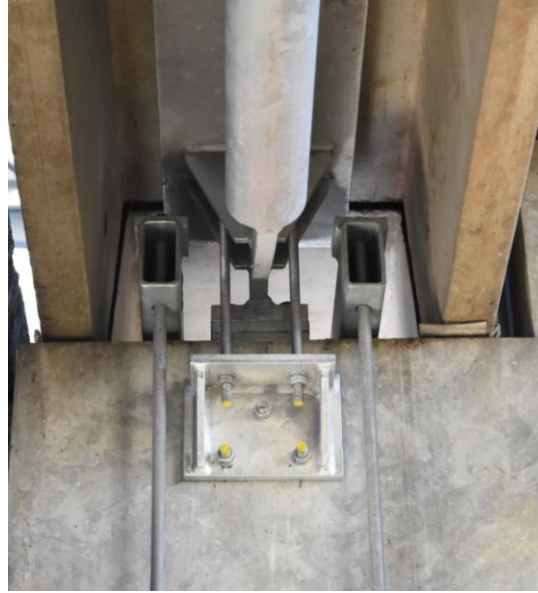
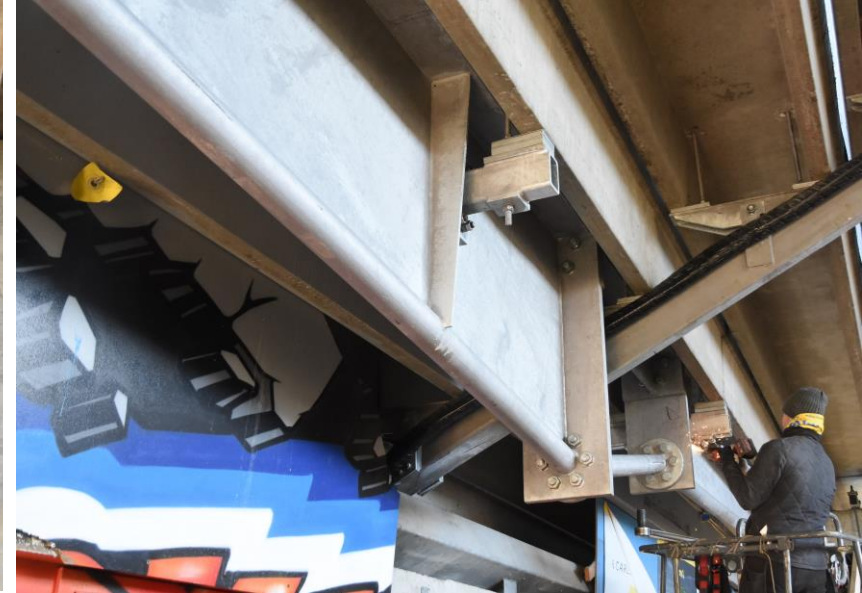
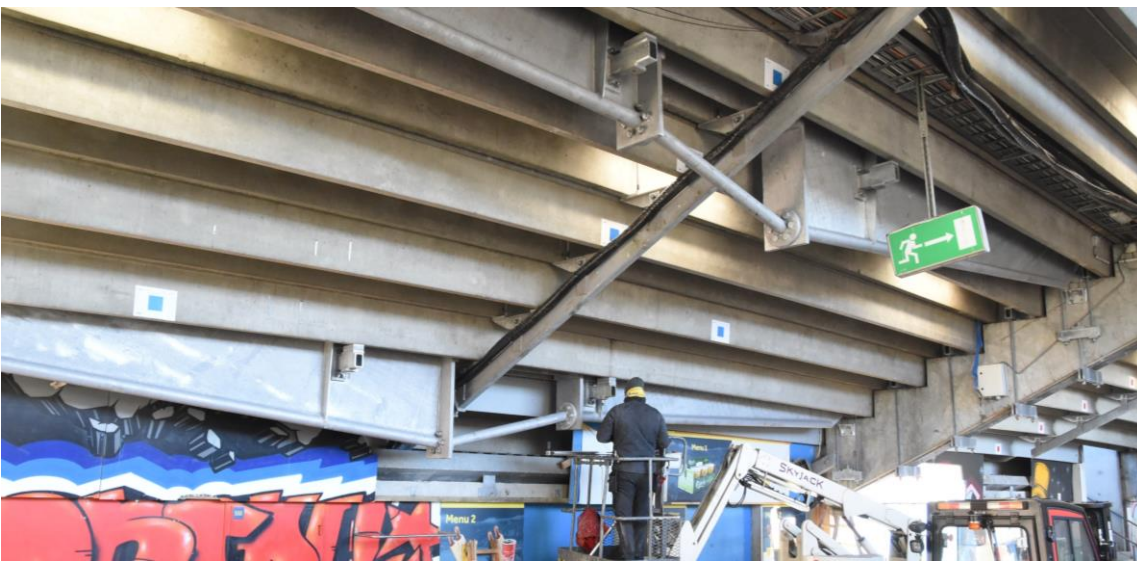
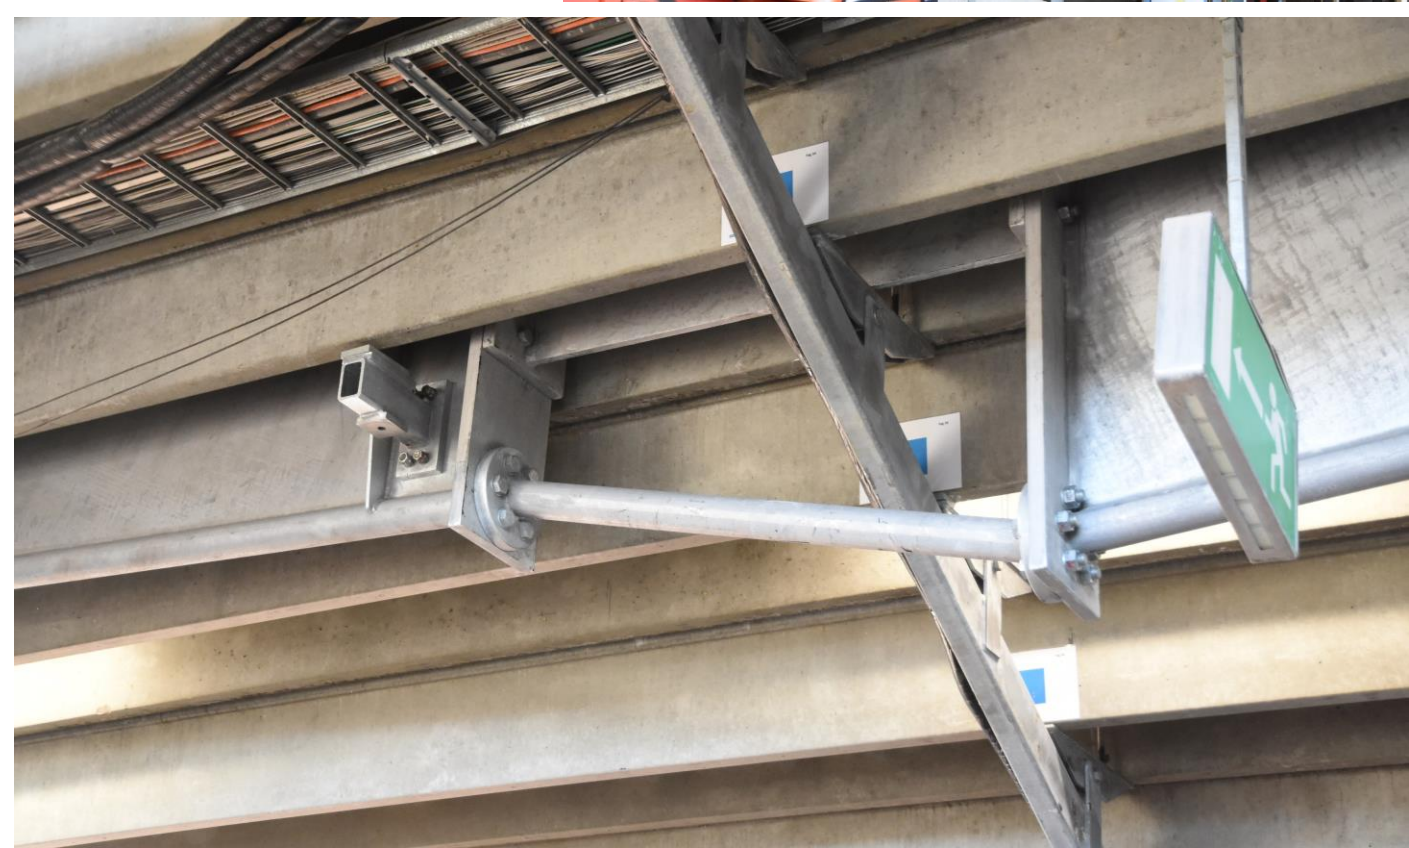
14 m longitudinal beams

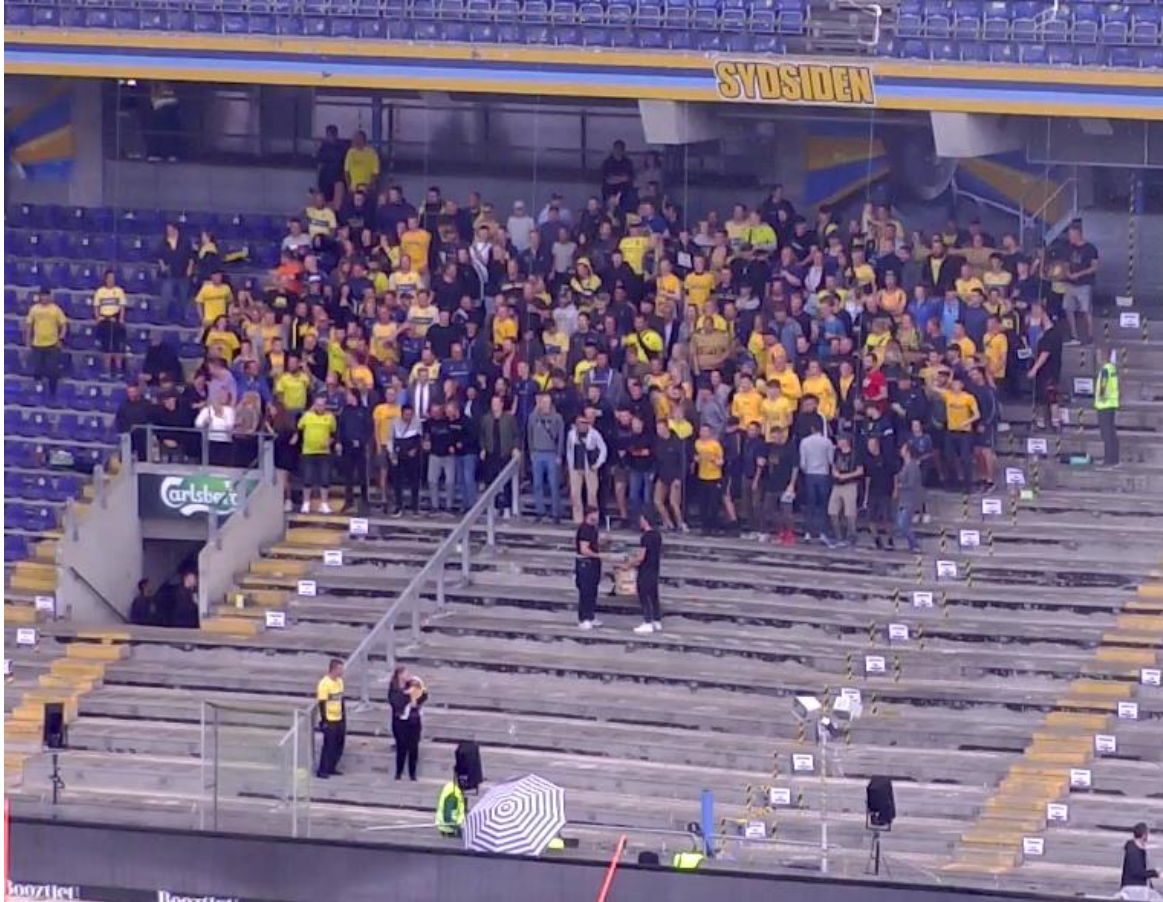
FULL SCALE LOAD TESTING WITH 350 PEOPLE

- > Allows for controlled/variable load intensity and frequency, and validation of effect of '14m beams'
- > Load testing aimed at reestablishing full capacity – in-game monitoring maintained for later validation.
- > Load testing in 2 critical/representative sections with/without '14m beams'
- > Simultaneous excitation of 8-17 elements due to cross bracings (21-42 people/elements)
- > Monitoring with accelerometers and DIC GoPro cameras
