BRIDGE ENGINEERING MEETS FOOTBALL

[SAFETY AND REHABILITATION OF EXISTING STADIUM STRUCTURES]

Dansk Ståldag
November 14, 2024

Monitoring & Analyses of Existing Structures
Ramboll Denmark

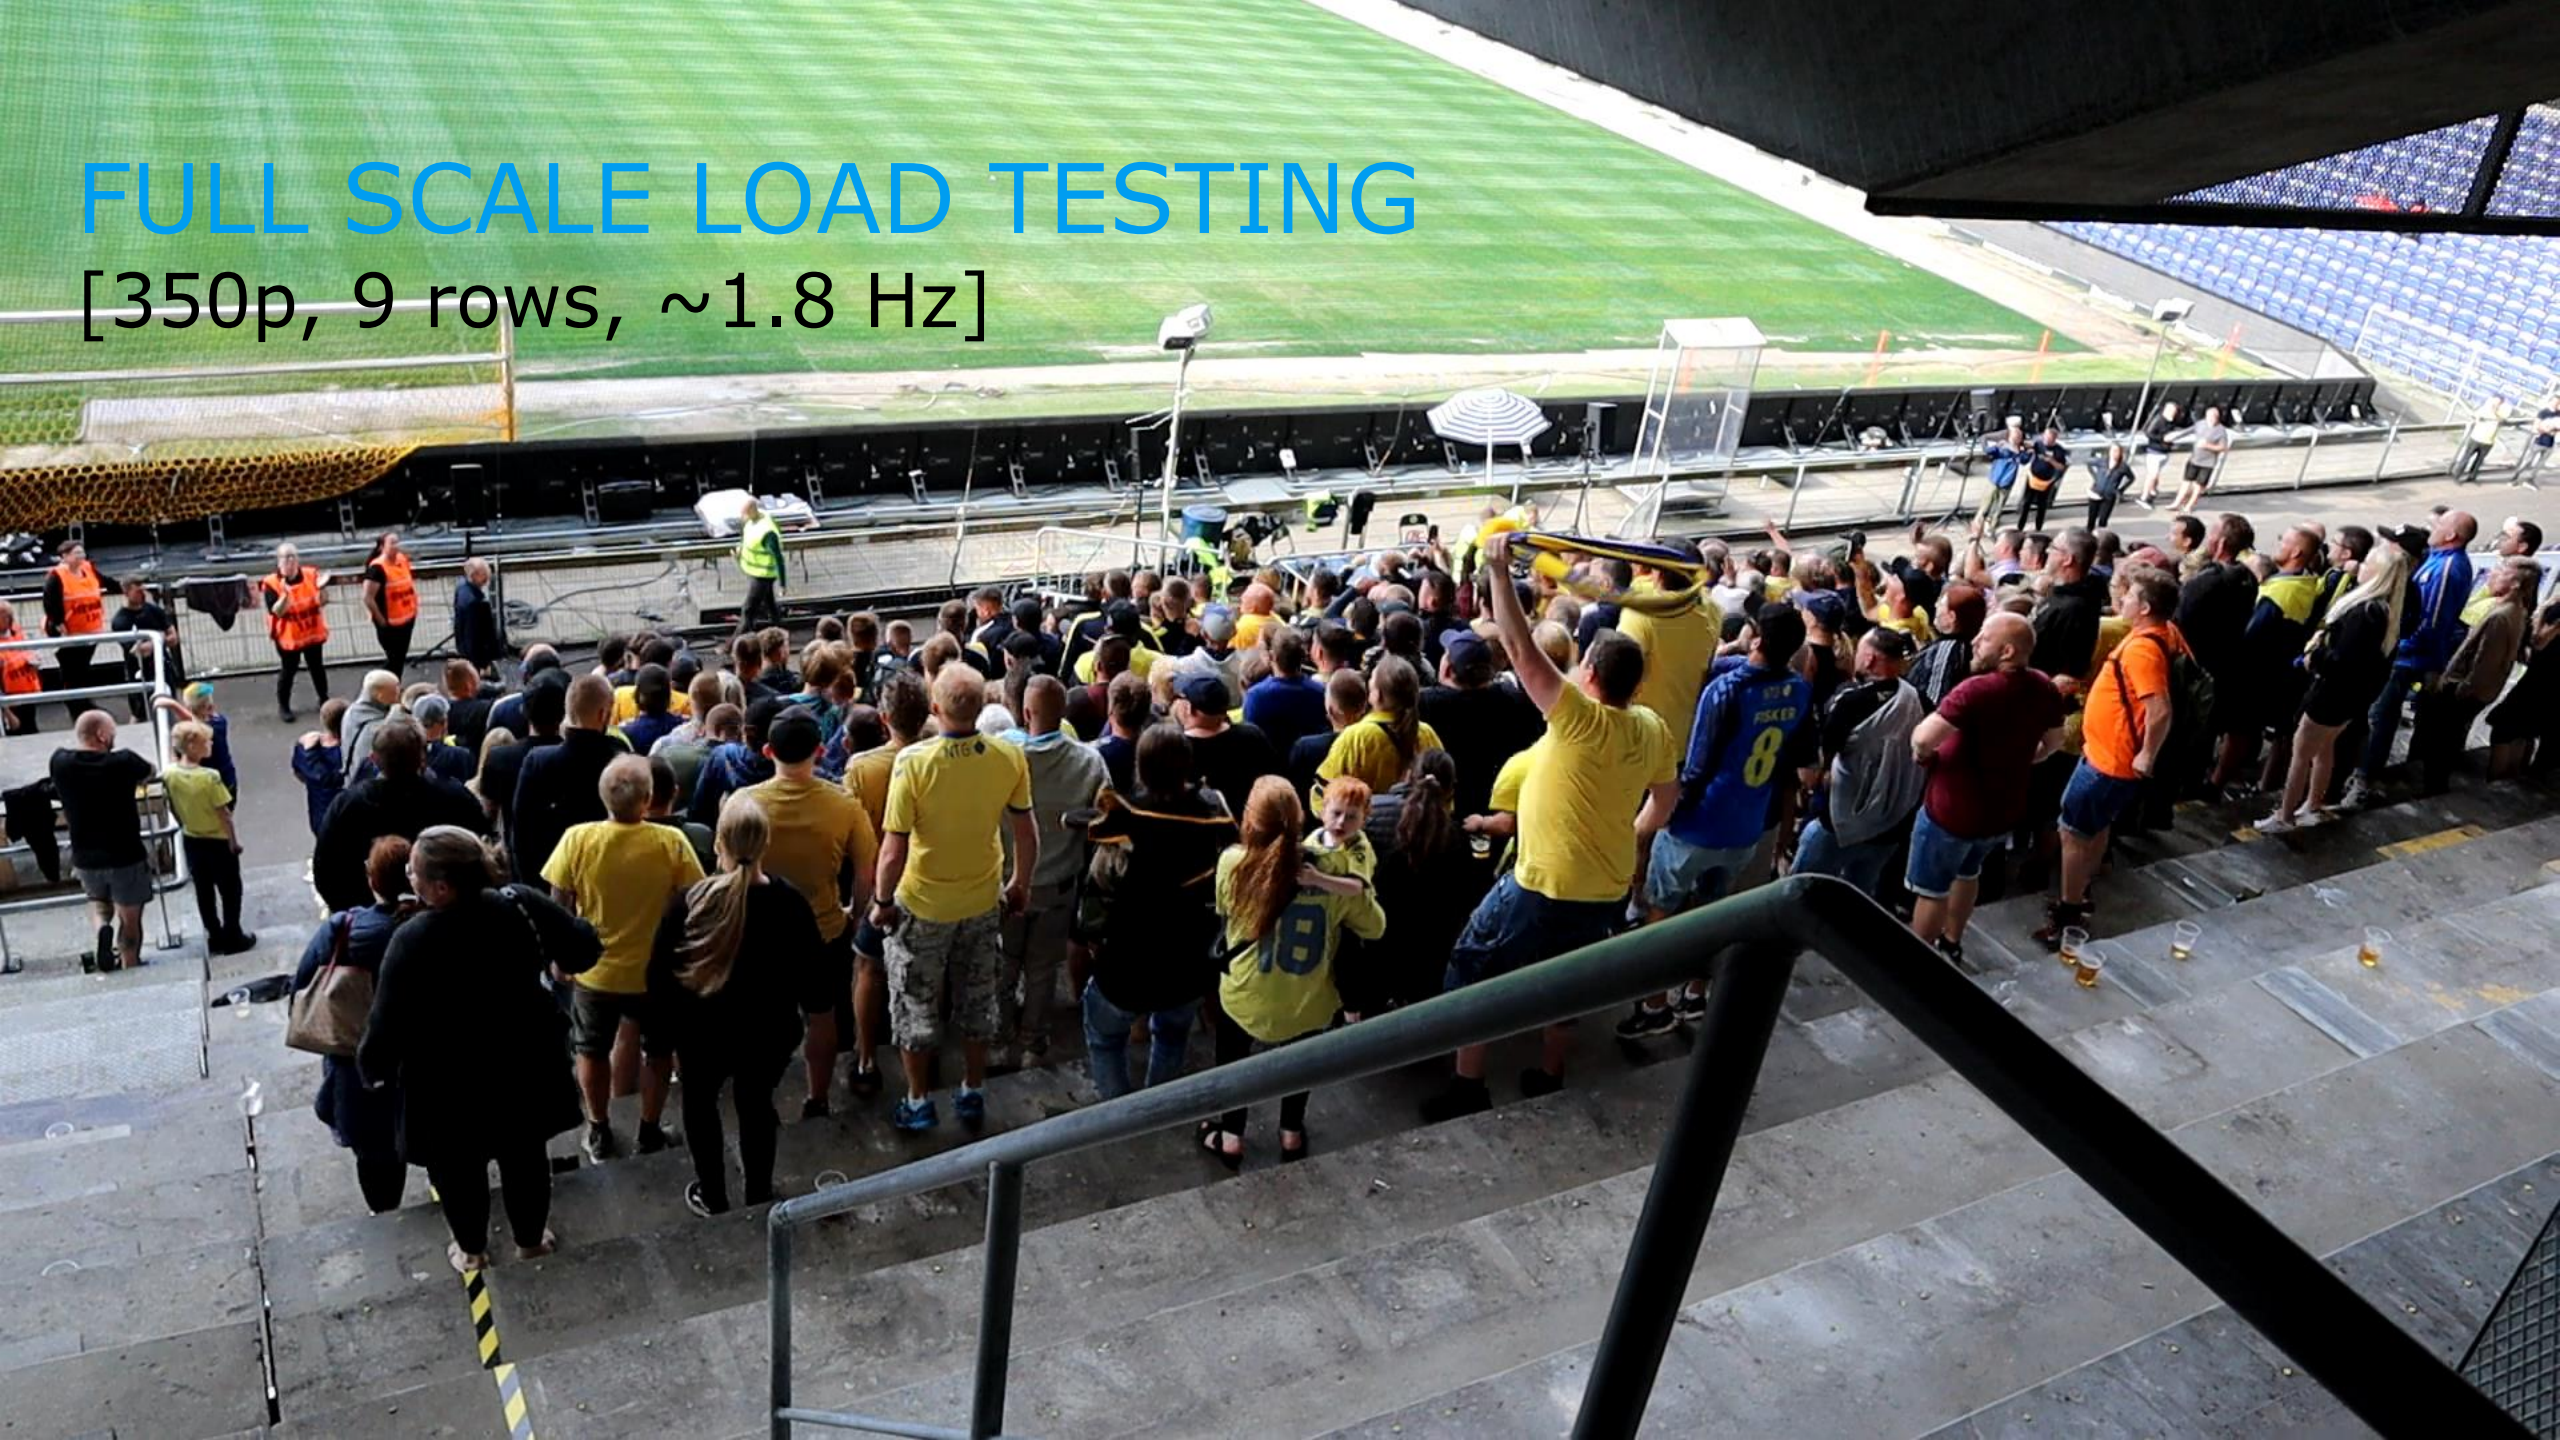
FULL SCALE LOAD TESTING

[350p, 9 rows, ~ 1.8 Hz]

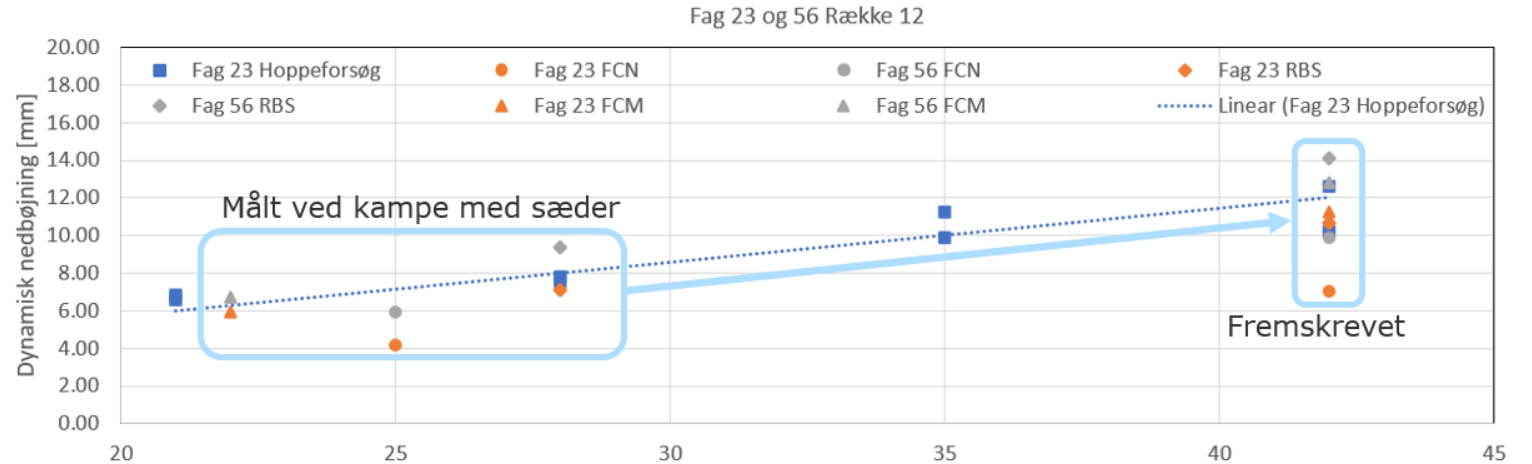
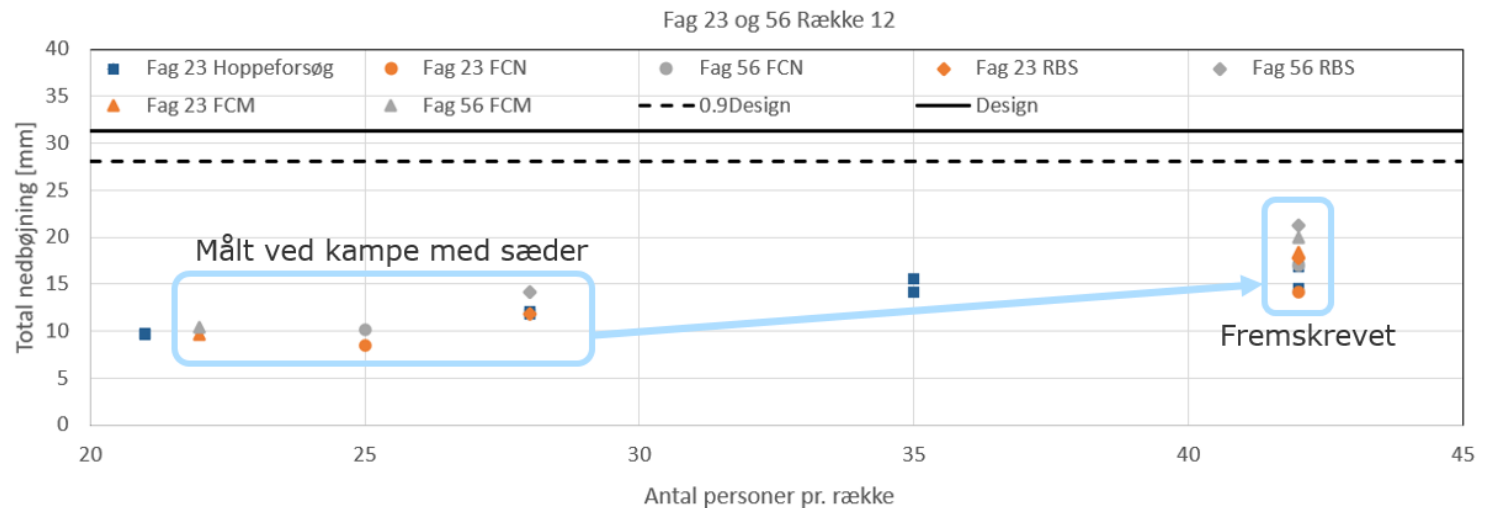
VALIDATION BY IN-GAME MEASUREMENTS

[Vibration measurements extrapolated]

- > 2750 people and seats installed
- > Extrapolation by 1:1 with #people to
- > Estim. 21mm total with 4700 people
- > 75% of acceptance criteria – good 😊!

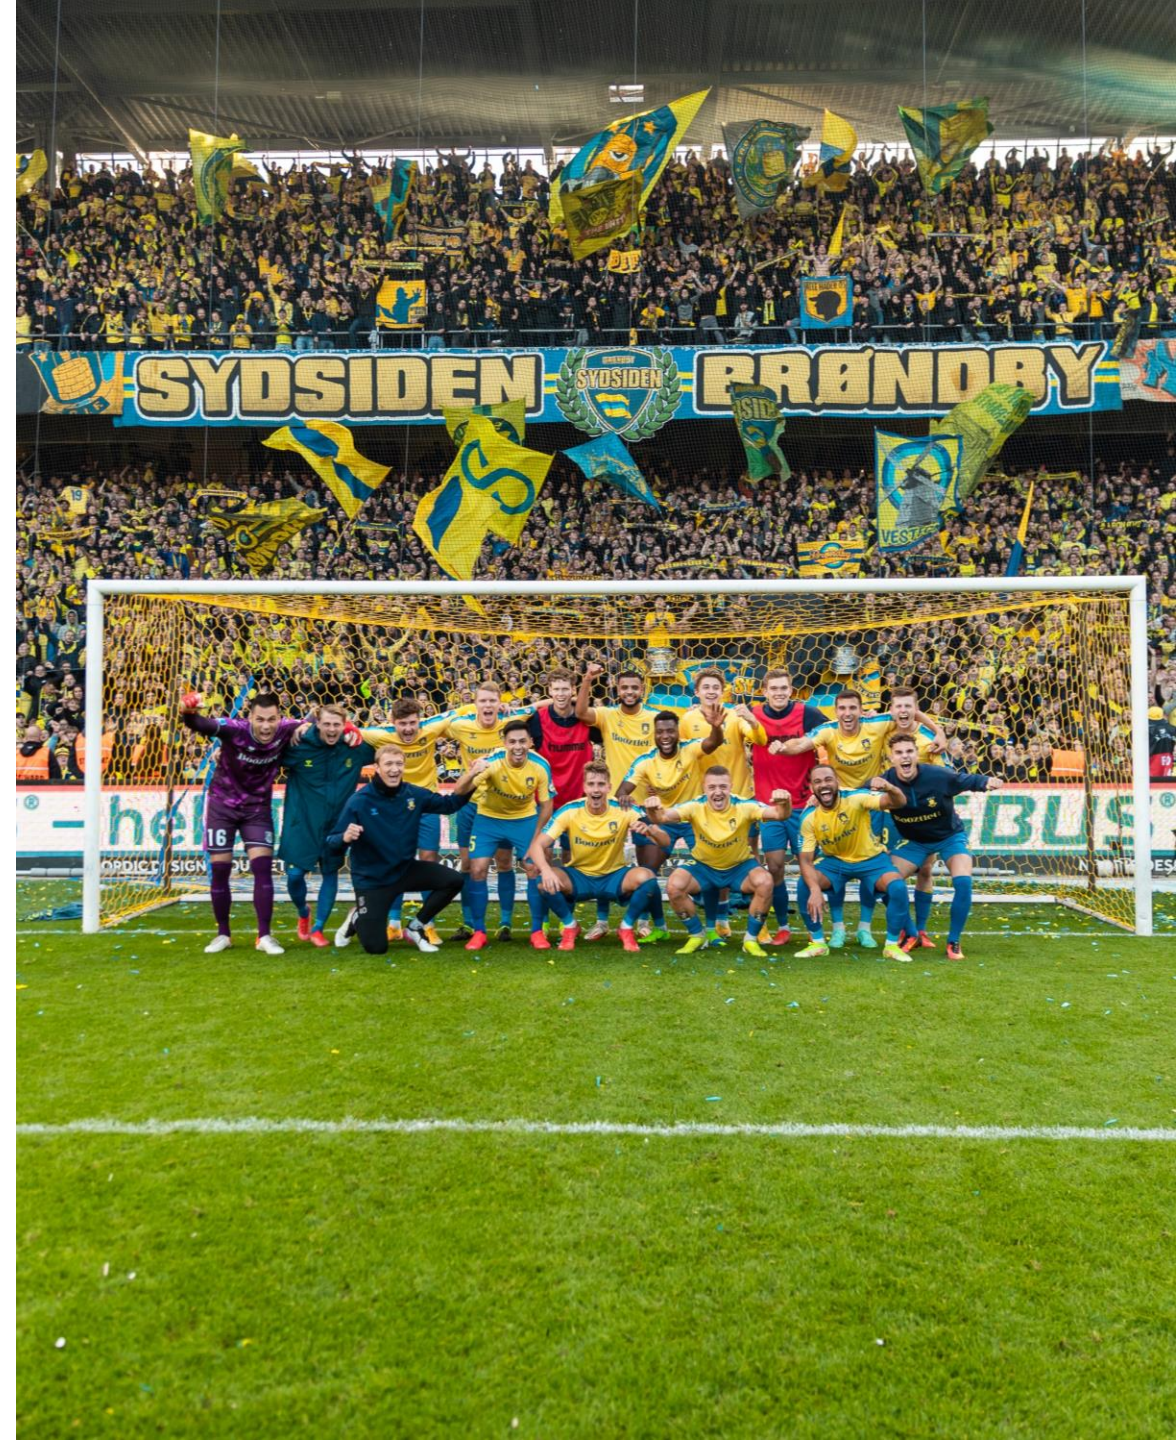
RECOMMISIONING

- > Back to full capacity – 4700 supporters & no seats
- > Brøndby-FCK, Sunday October 24 2021 (result 3-1 😊)
- > Max total deflections 22 mm in central spans
- > +20% increase compared to load testing – was expected

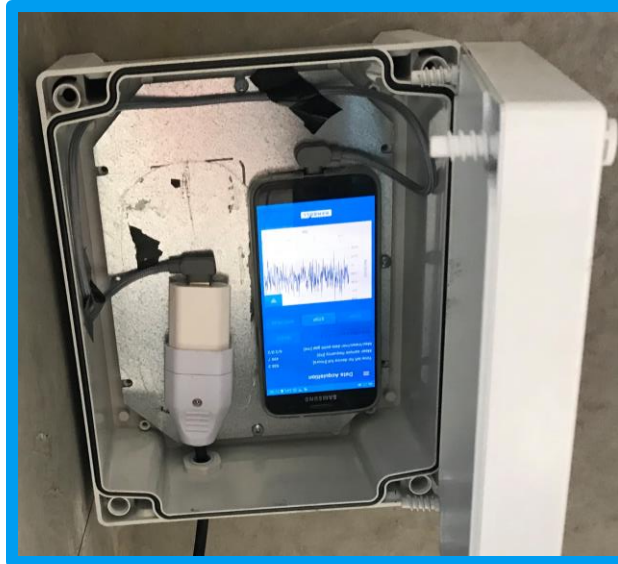
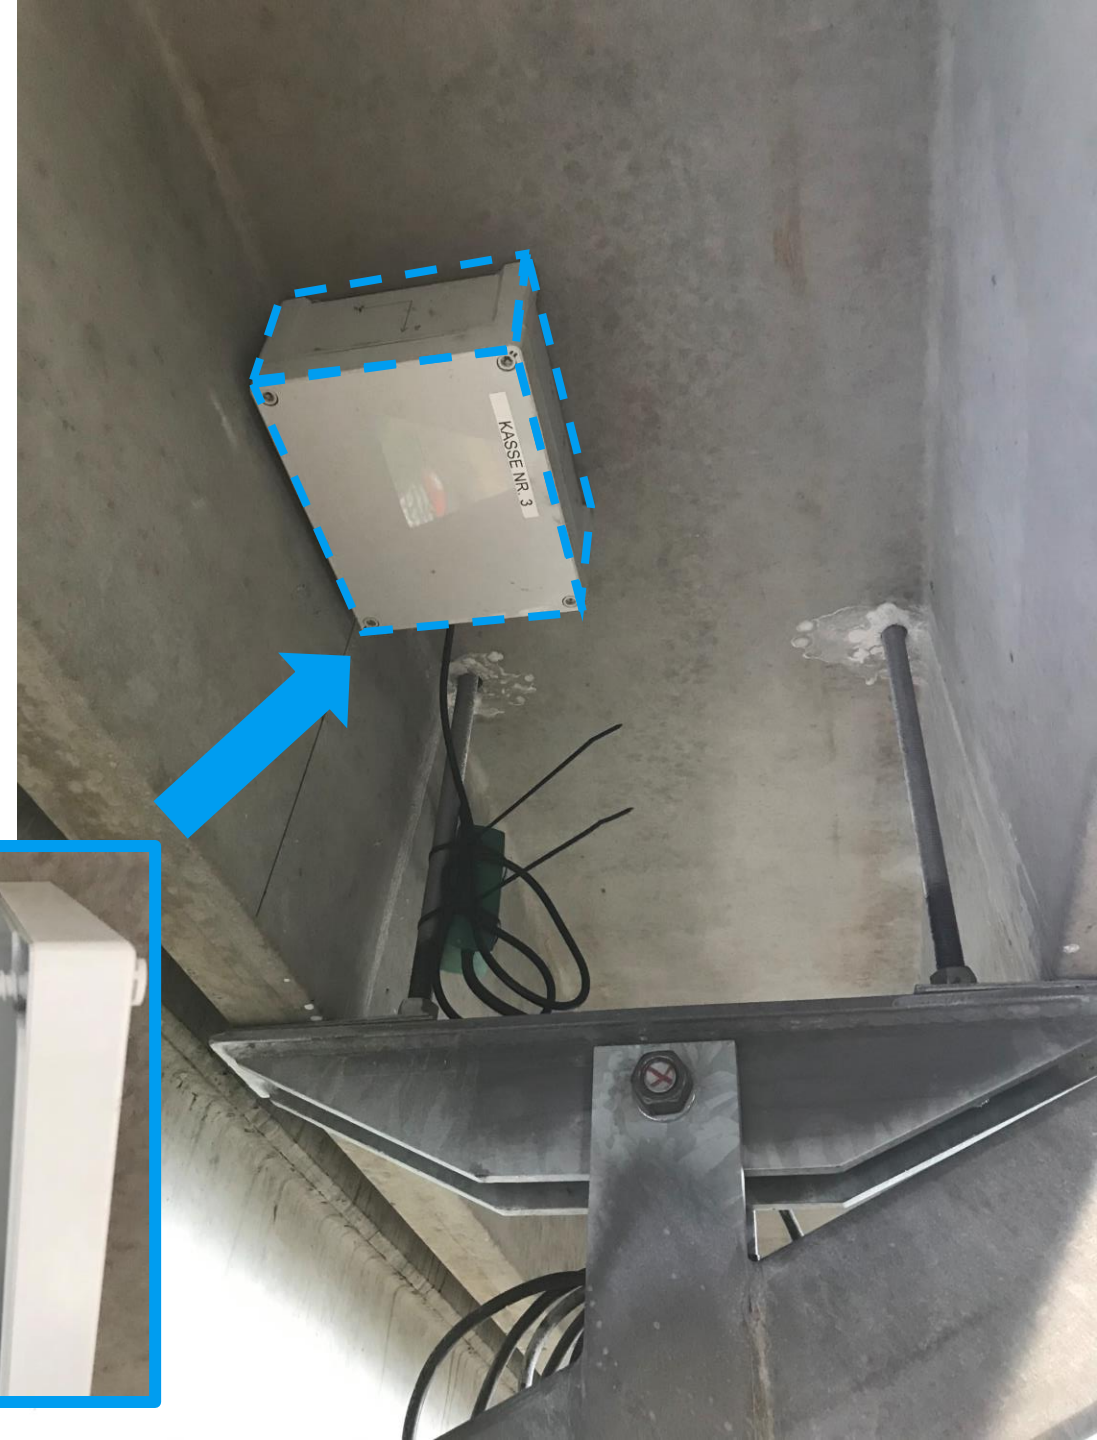
PERMANENT MONITORING

- > Permanent monitoring of vibrations for continuous safety
- > Cost-effective monitoring system with RamVib smartphones
- > Remote online access, automatic cloud upload and analysis
