WEATHERING STEEL 30 YEARS OF EXPERIENCE IN BANEDANT

Peter Holmstrøm, Rambøll Dansk Ståldag 8. November 2018

INTRODUCTION

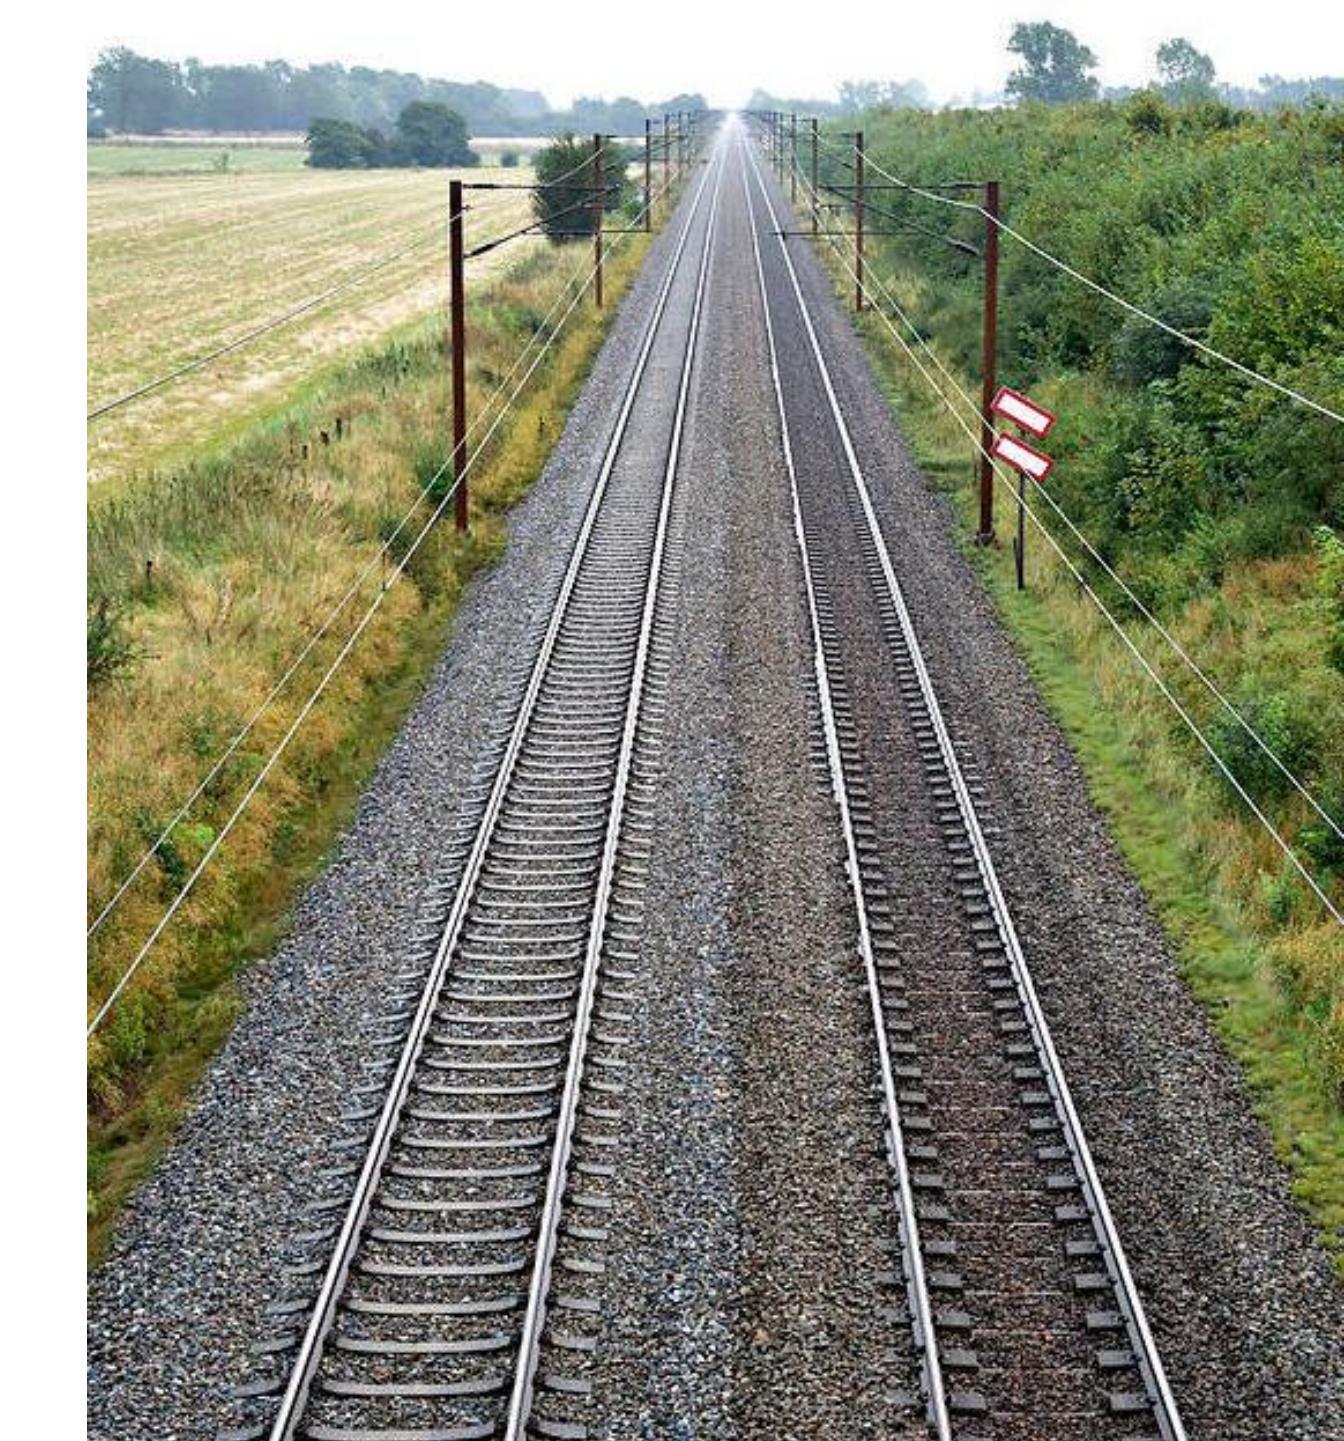
- 1st major electrification project in 1980s
- State of the art design required 'year 2000 design'
- 50-years service life with minimum maintenance
 - Concrete
 - Aluminium

- Stainless steel
- Weathering steel

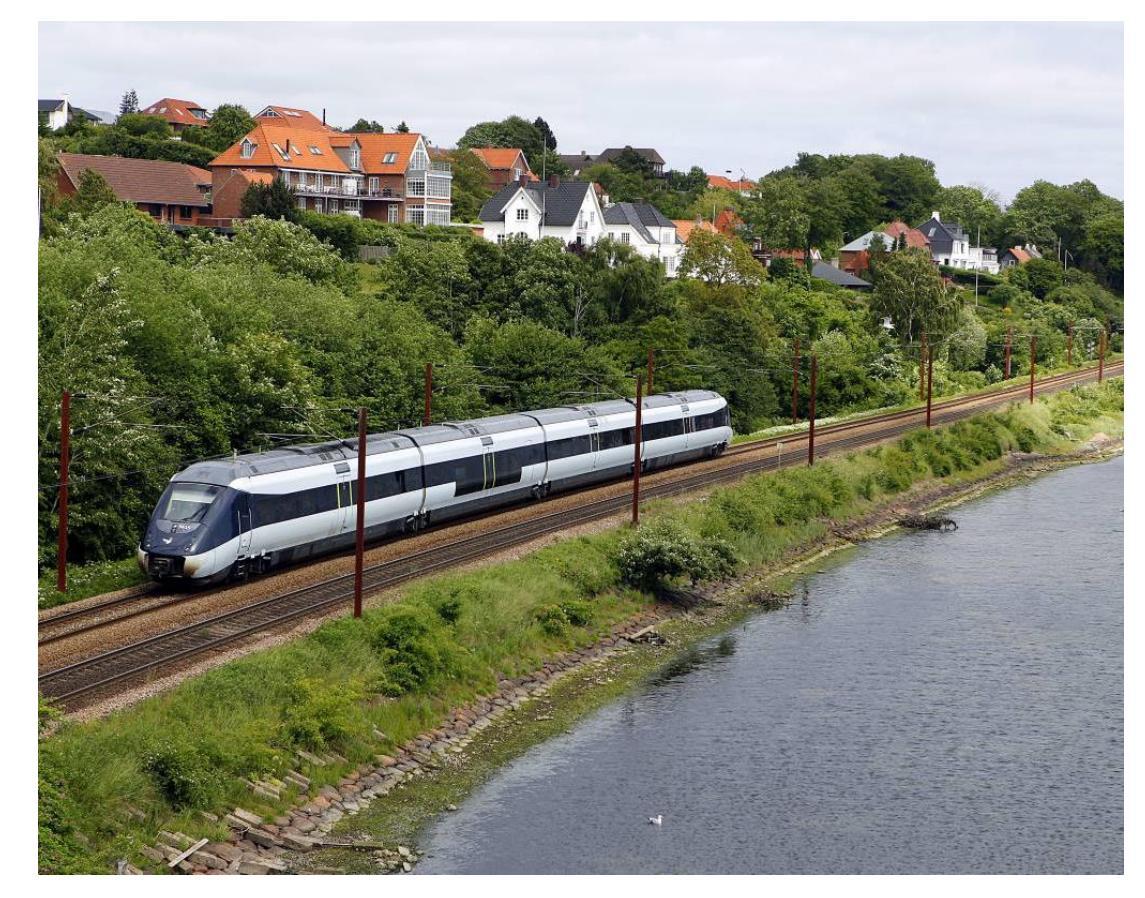
- Aesthetical impact on the scenery of the country
 - 2100km single track
 - 40.000 masts
- Focus on architectural design
- Use of clamps
- Innovative design awarded ECCS design award in 1987
- Performance of weathering steel has been registered since the beginning

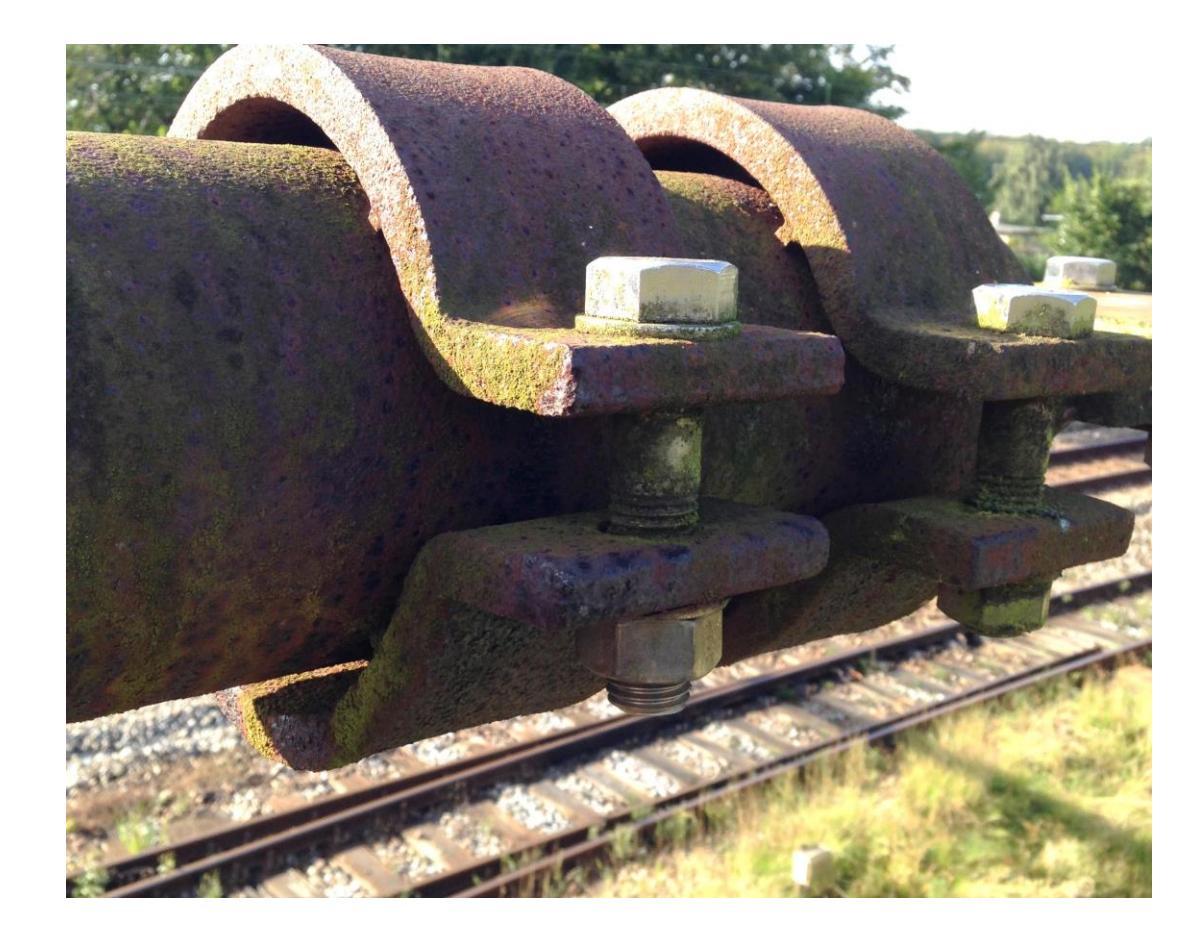
- Gap between structures, if sufficient contact pressure cannot be ensured
- i.e. thin plates and clamps
- Avoid ponding water or cavity effects
- Avoid collection of corrosion products or dirt
- Discolouring of structure below (bridges)
- Stainless bolts
- Avoid self-adhesive stickers
- Avoid graffiti

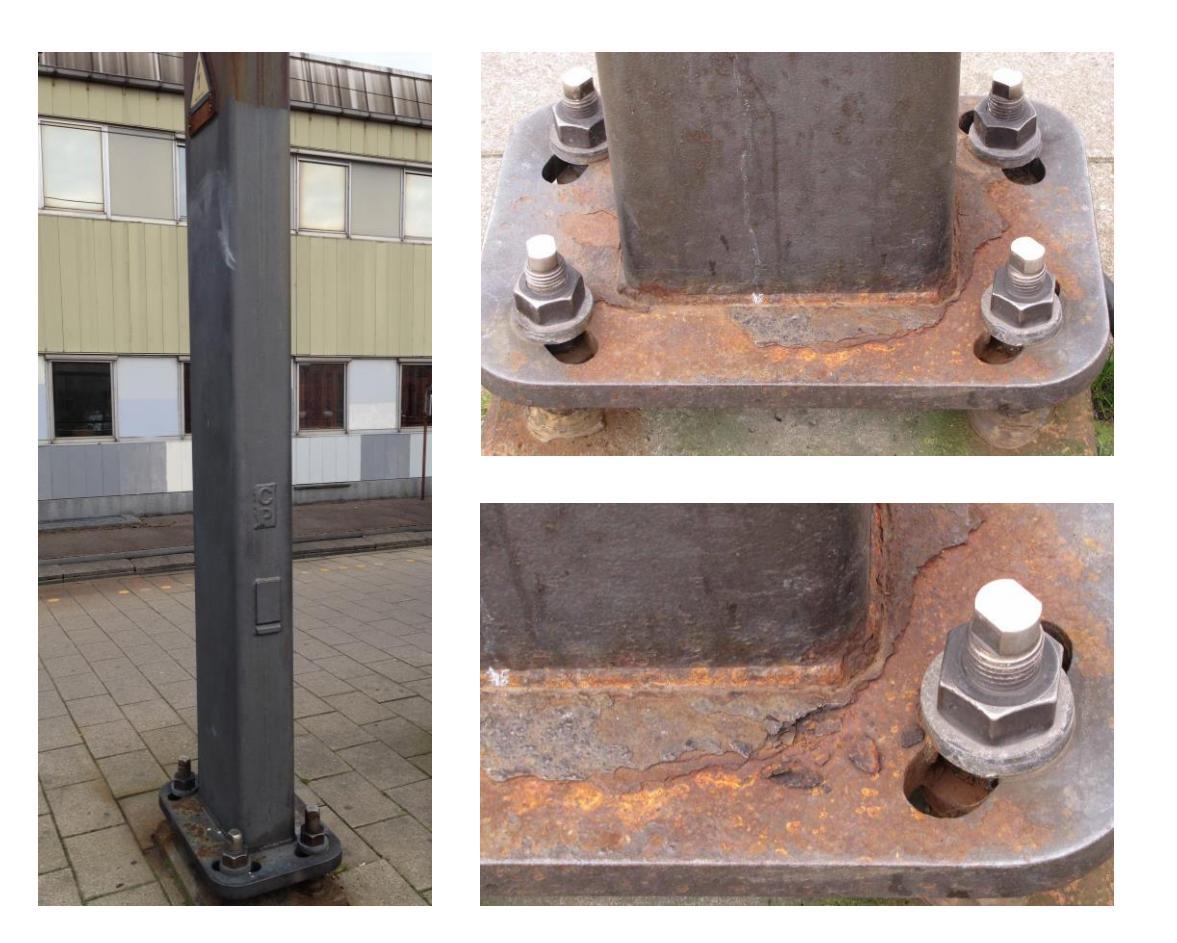
- Easy removal of offensive graffiti: Paint on top
- Can lead to accelerated corrosion if not done correct
- Horizontal faces most critical

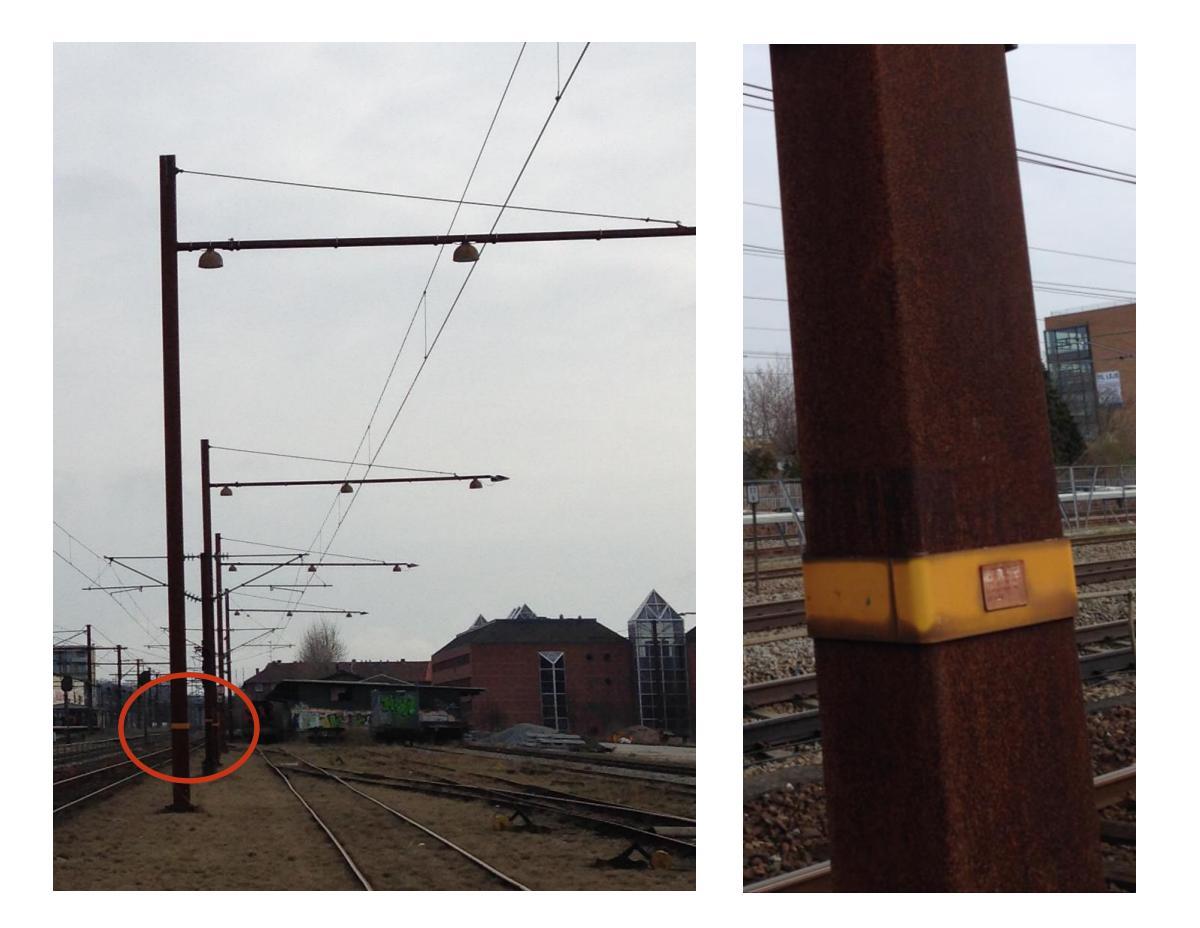
- Initially self-adhesive
- Replaced with spacers in corners to keep gap between steel and yellow tape

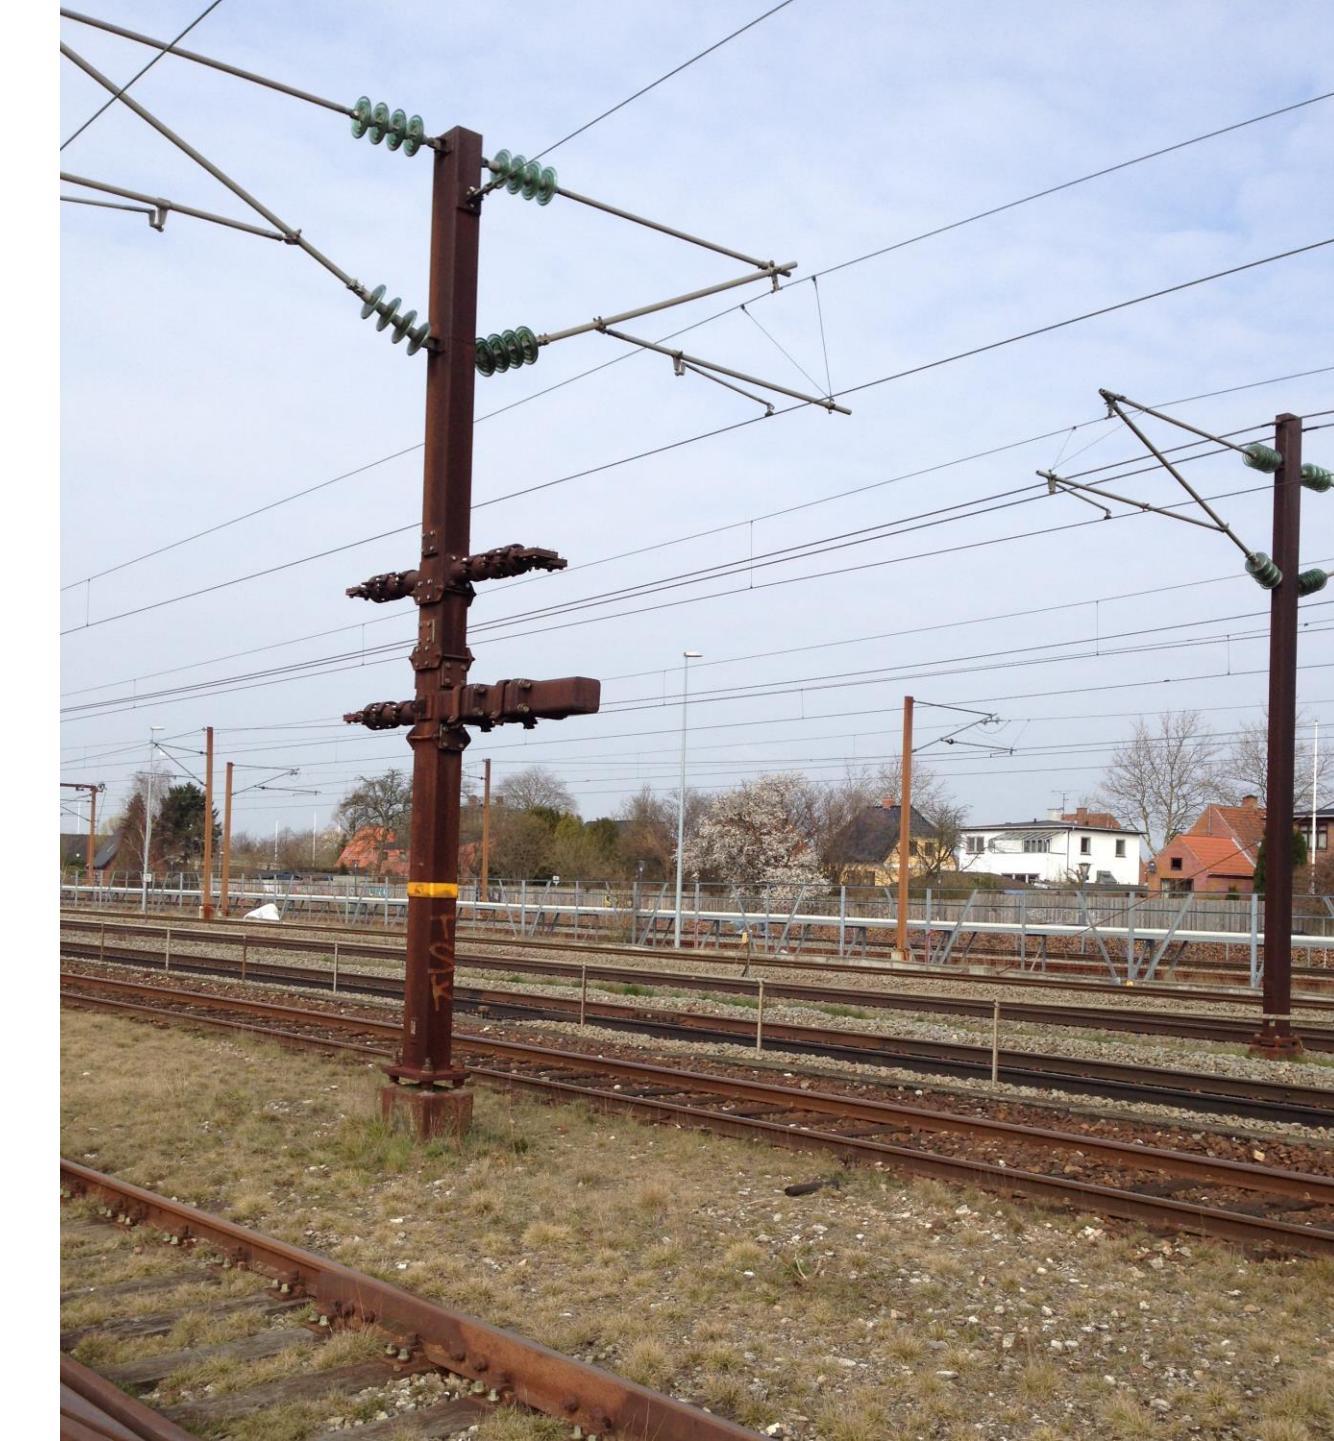
- Designated test masts
- Monitoring corrosion conditions in details
- Determine general corrosion rates
- 6 different locations in Denmark Rural, industrial and coastal area
- Test regime of 238 test plates

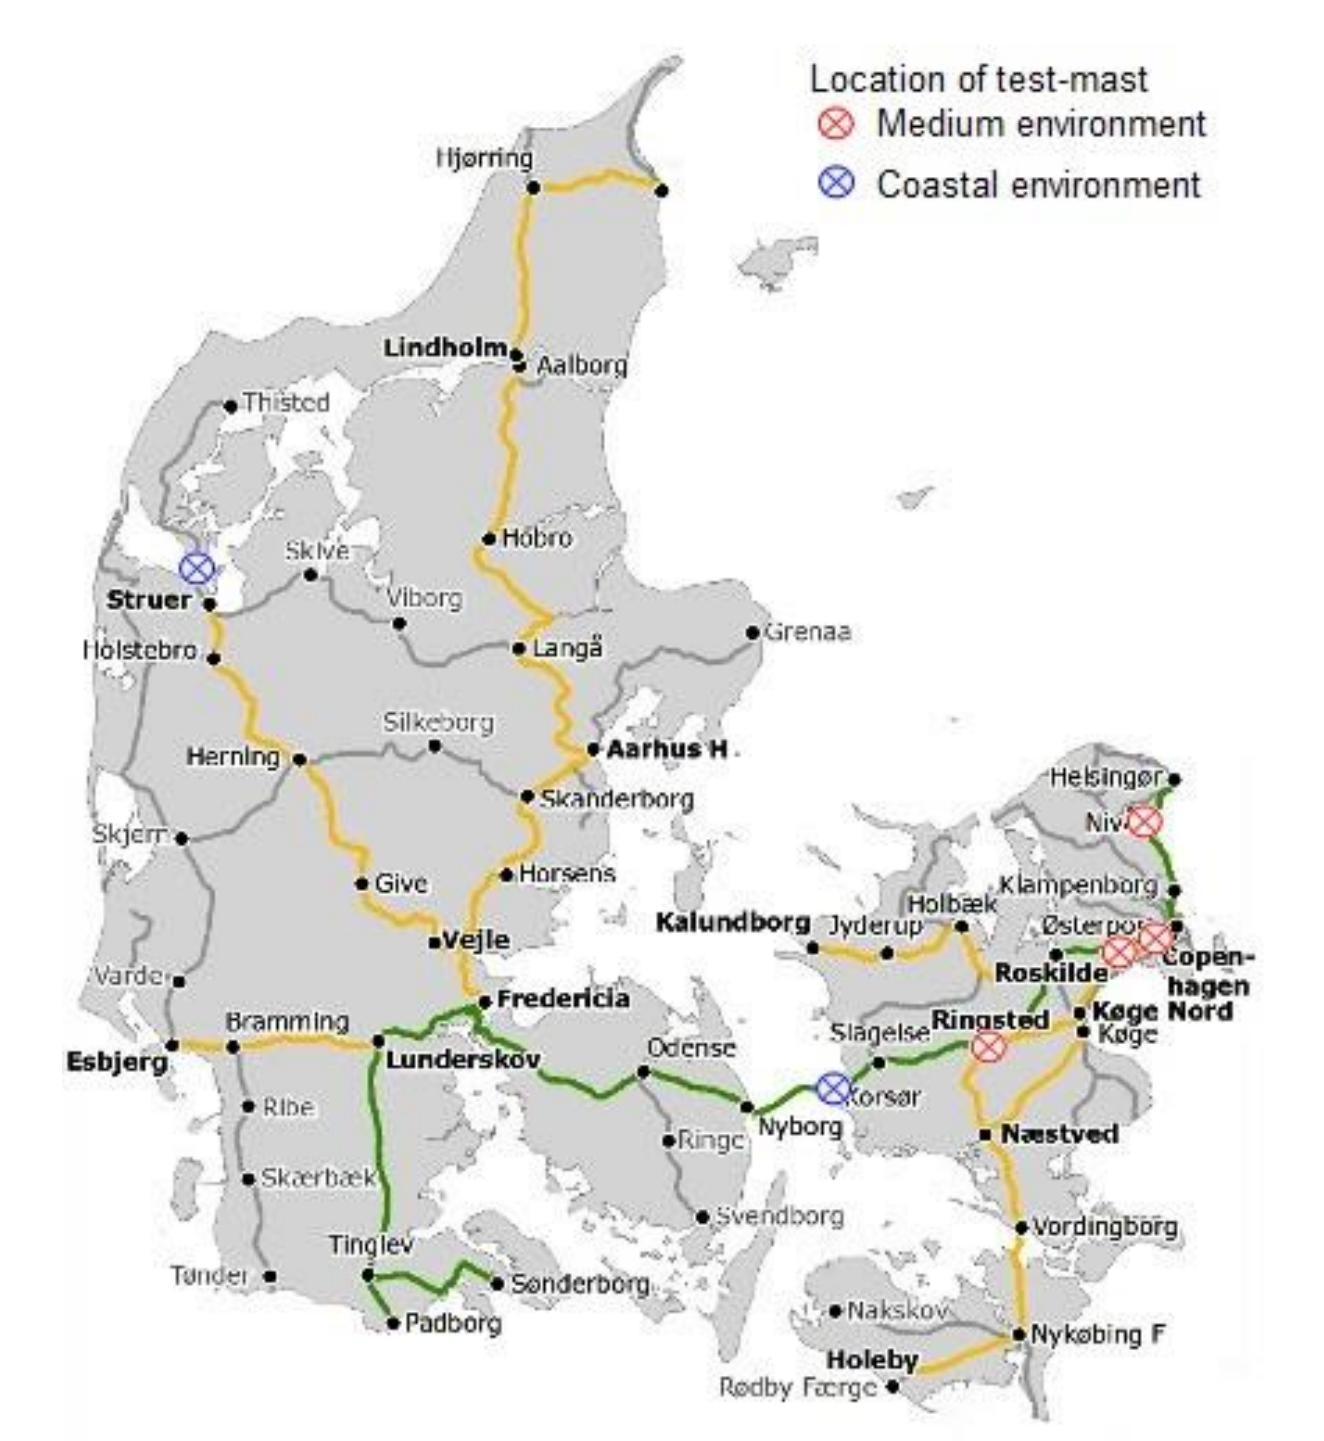
- Designated test masts
- Monitoring corrosion conditions in details
- Determine general corrosion rates
- 6 different locations in Denmark Rural, industrial and coastal area
- Test regime of 238 test plates

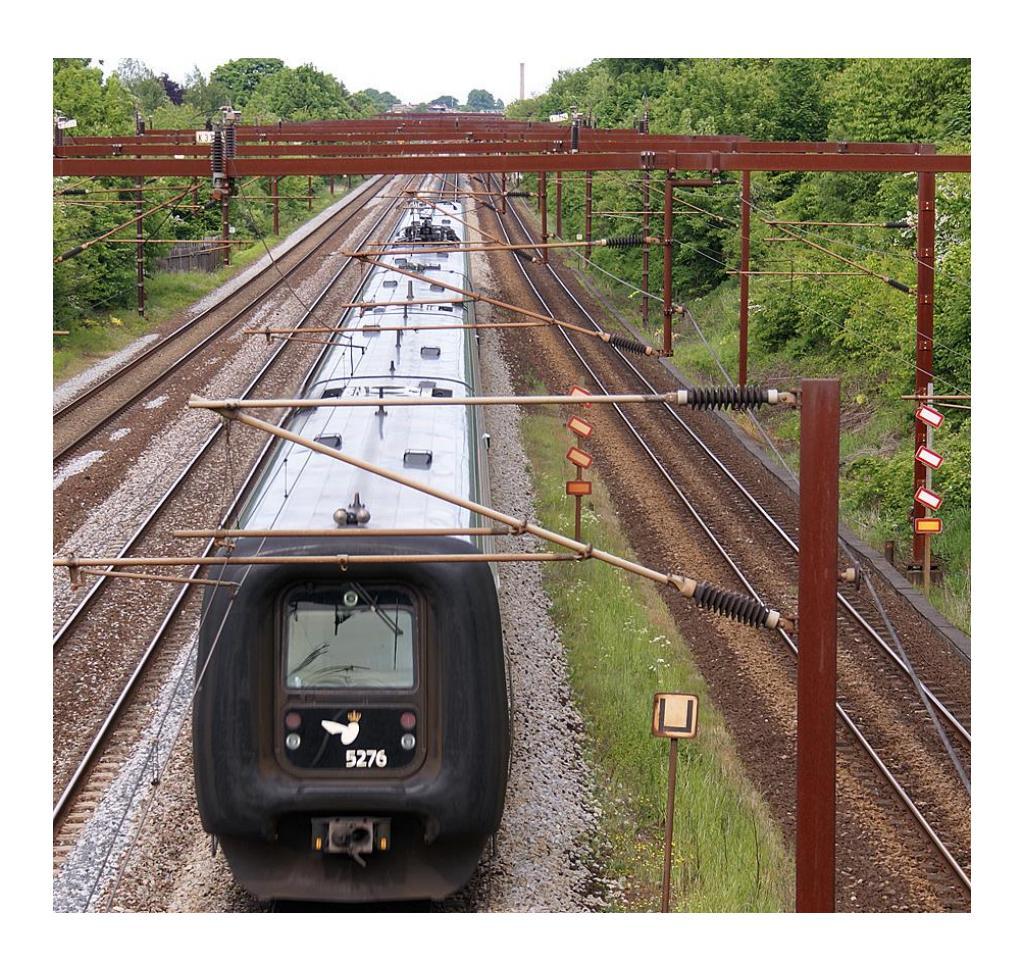
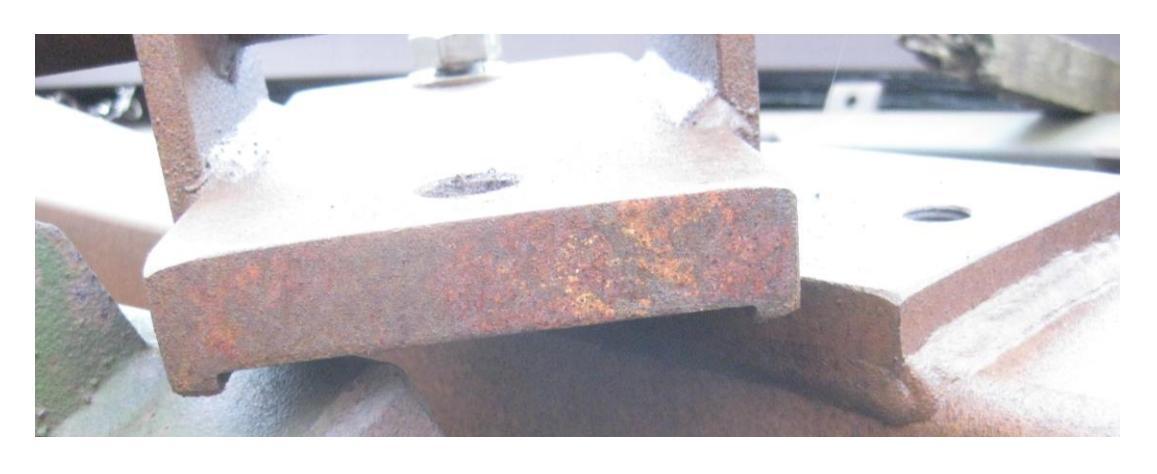
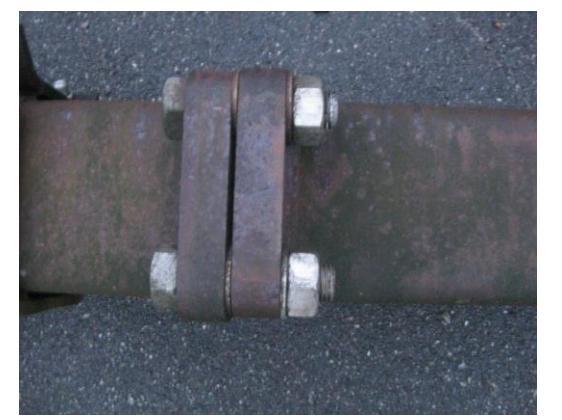
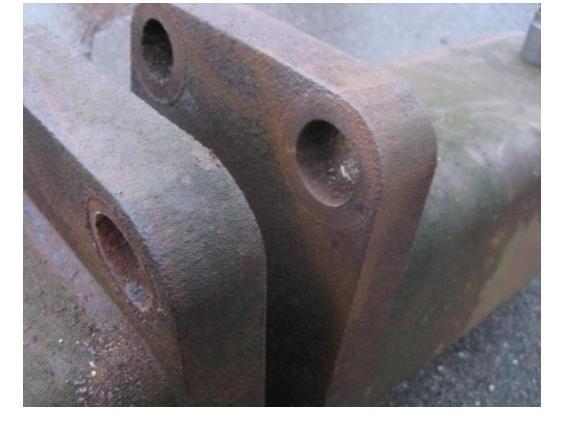
THE DETAILS STILL WORK AFTER 30 YEARS

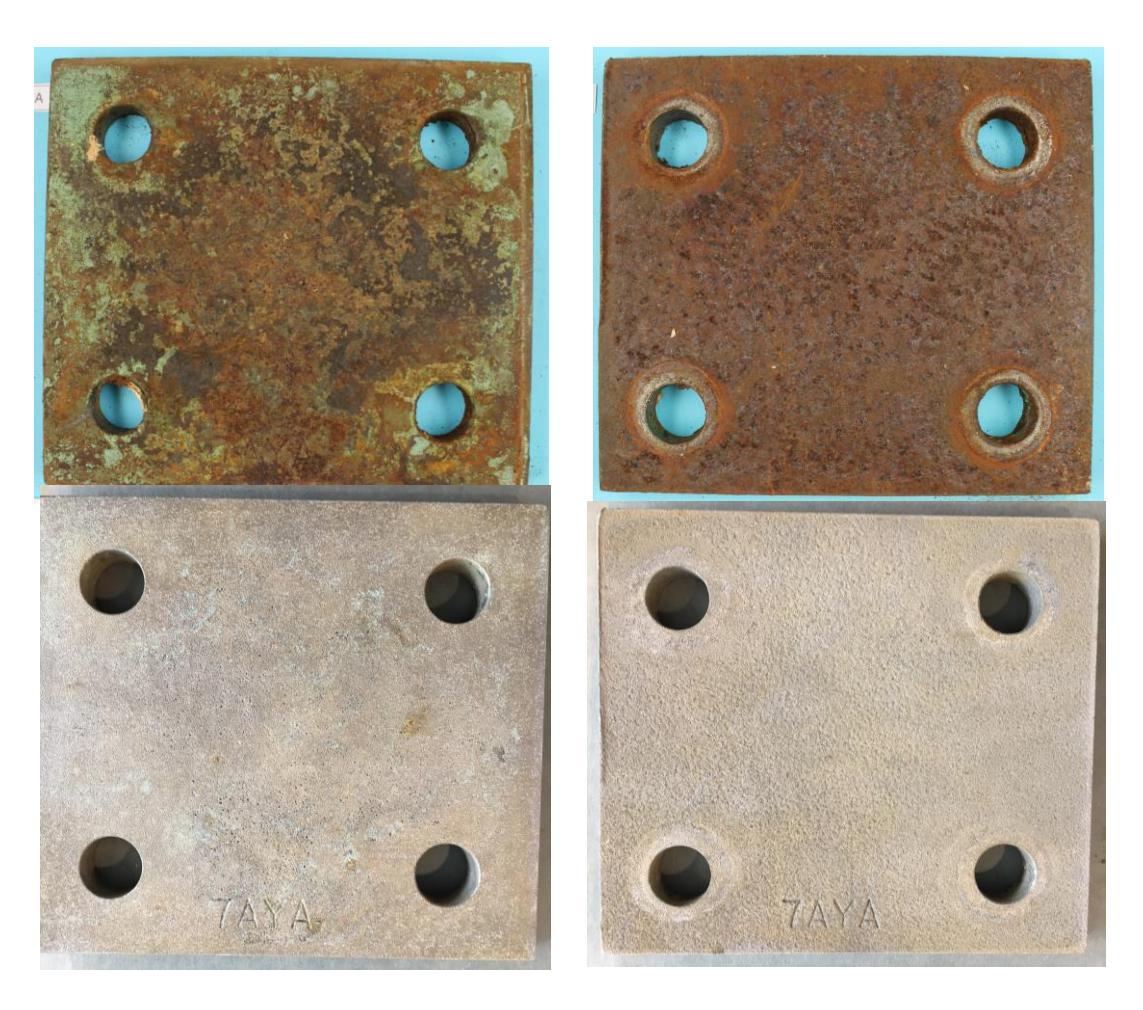
- Given direction of exposure
 Up / down / vertical
- Plates cleaned chemical not mechanical
- Weight loss
- Back side and edges => conservative values
- Effect of stainless bolts?

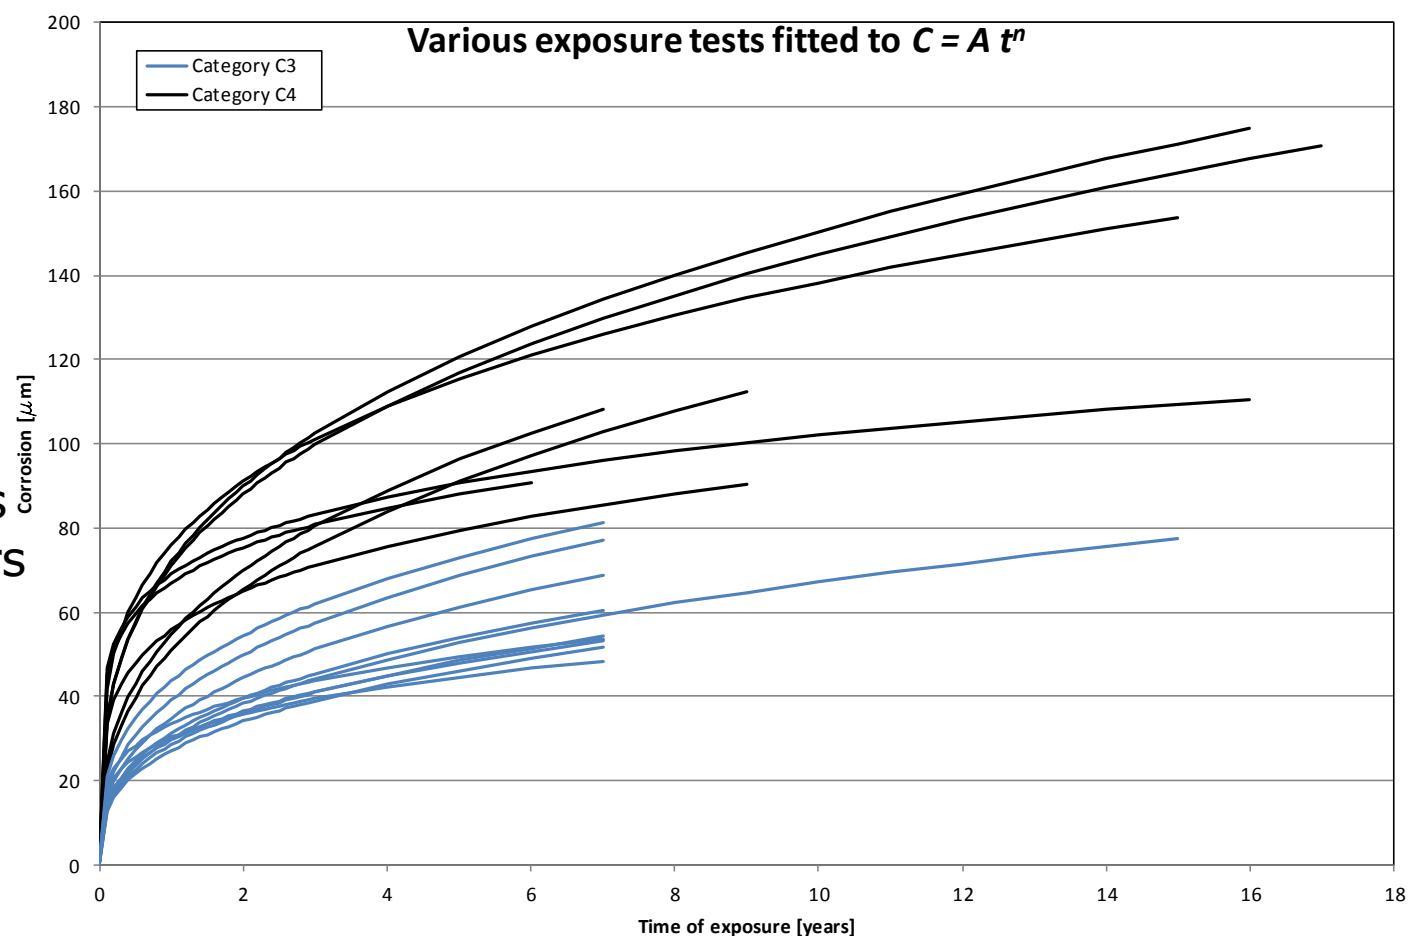
- Sacrificial thickness chosen for design
- Corrosion rate decreases over time
- Experimental data not always easy to compare direct
- In general most exposure tests gives values after max 10 years
- Which curve is the one to use?

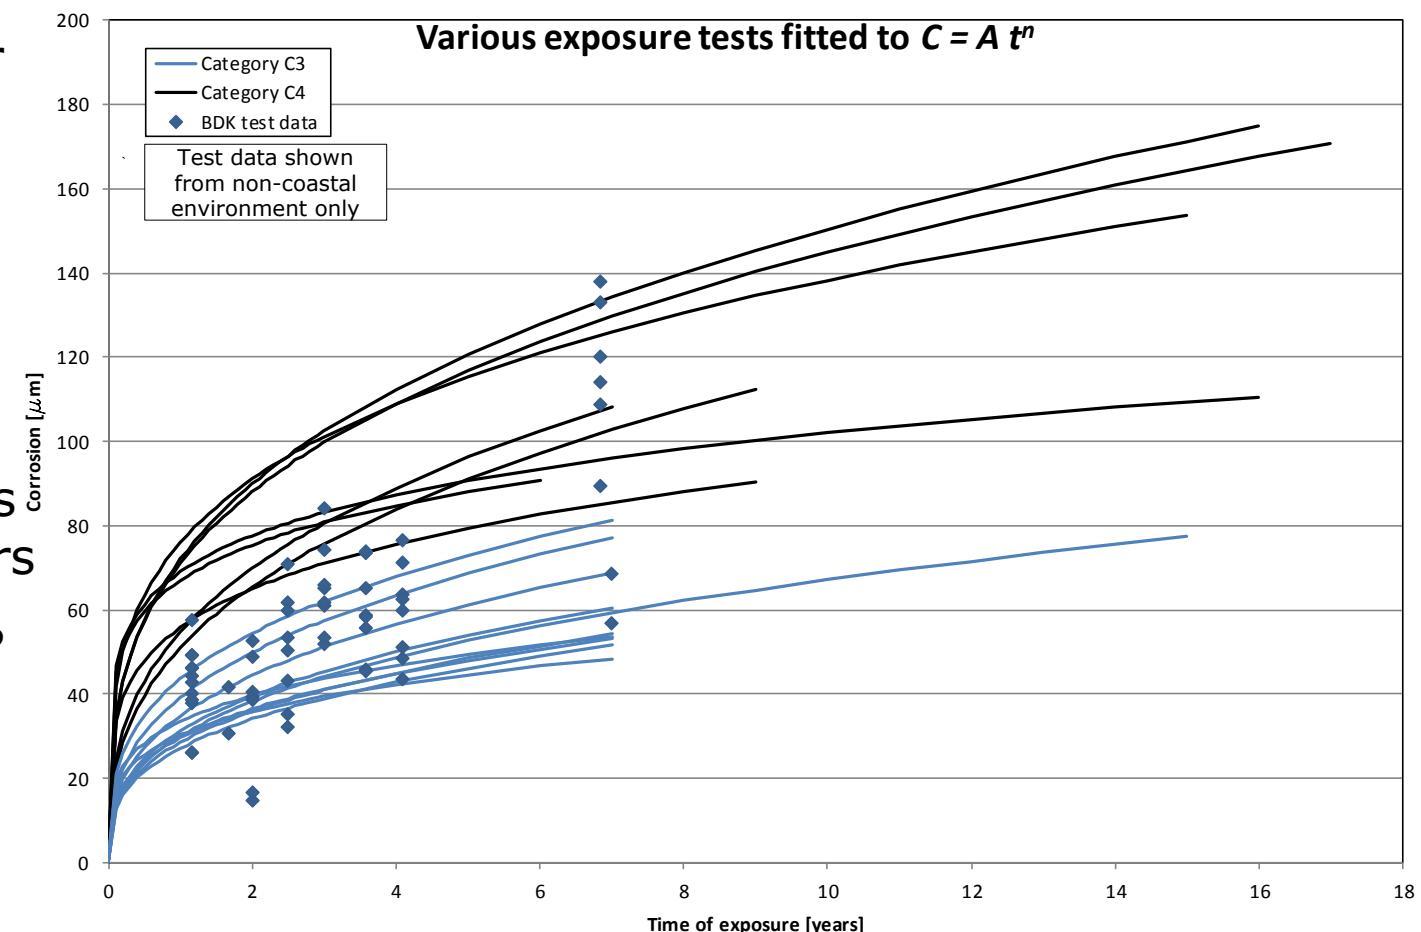
- Sacrificial thickness chosen for design
- Corrosion rate decreases over time
- Experimental data not always easy to compare direct
- In general most exposure tests gives values after max 10 years
- Which curve is the one to use?

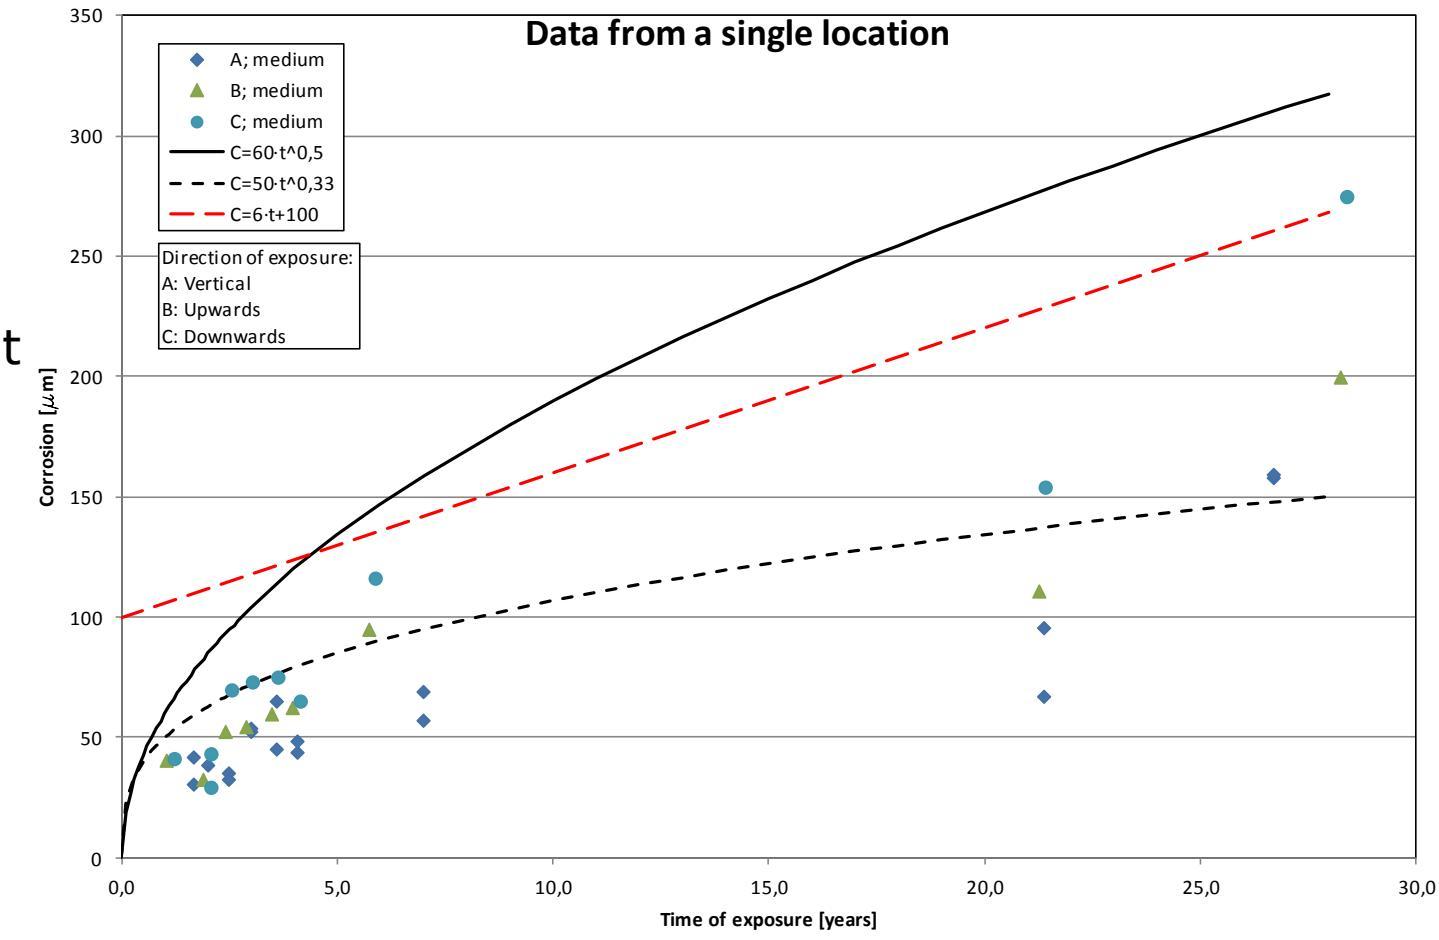
- Unique data from 30 years exposure
- Clear tendency on orientation during exposure
- Clear tendency on environment coastal vs. non-coastal (medium)

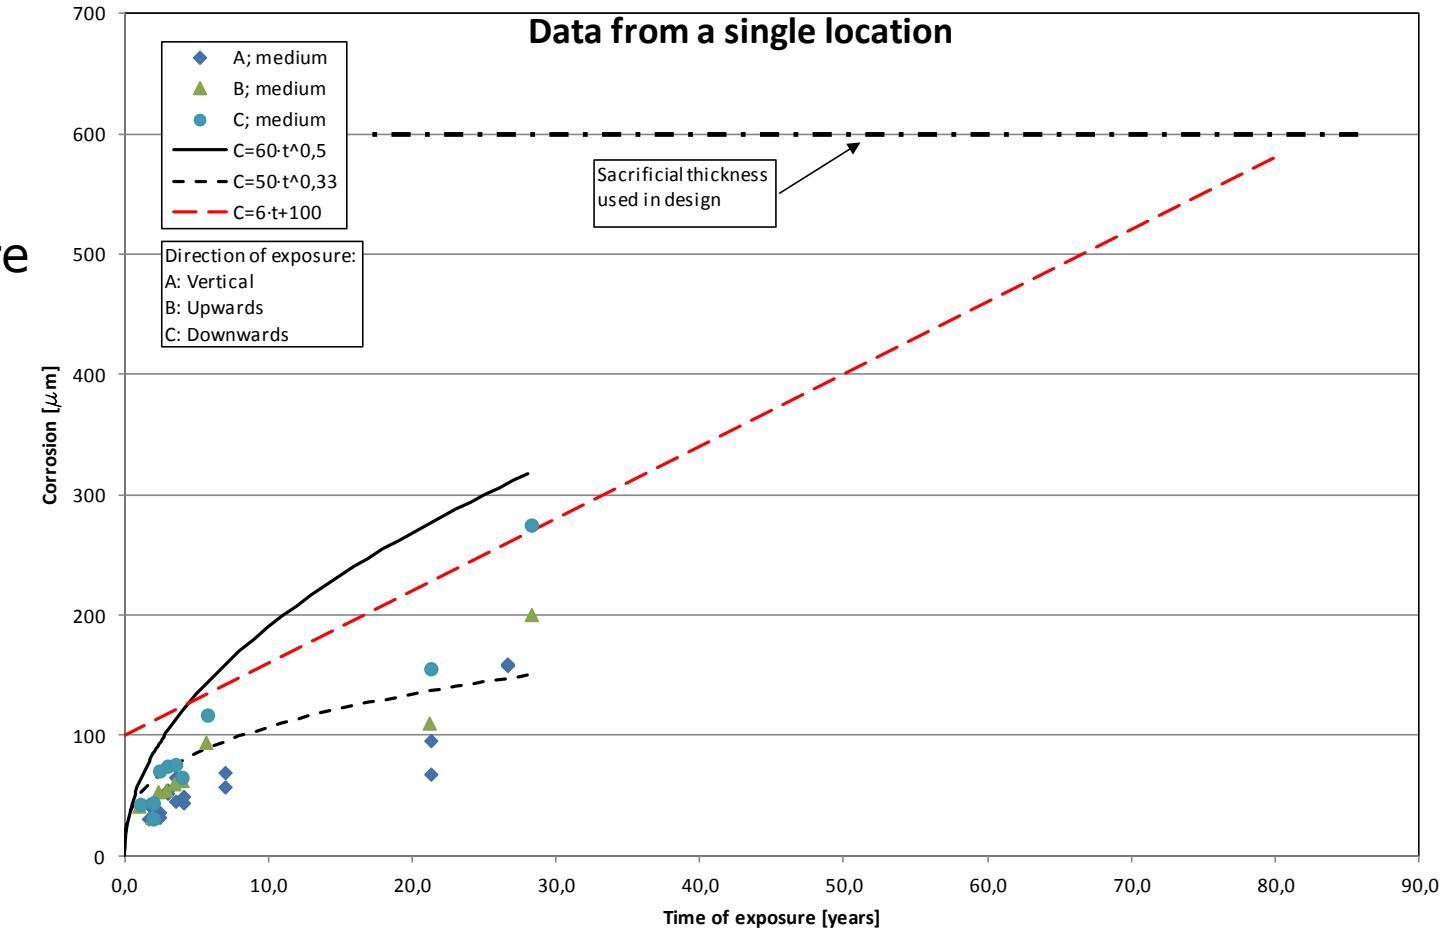
- Simplifying to steady-state corrosion rate
- Indication of expected service life exceeding 80 years or more
- At least for rural conditions

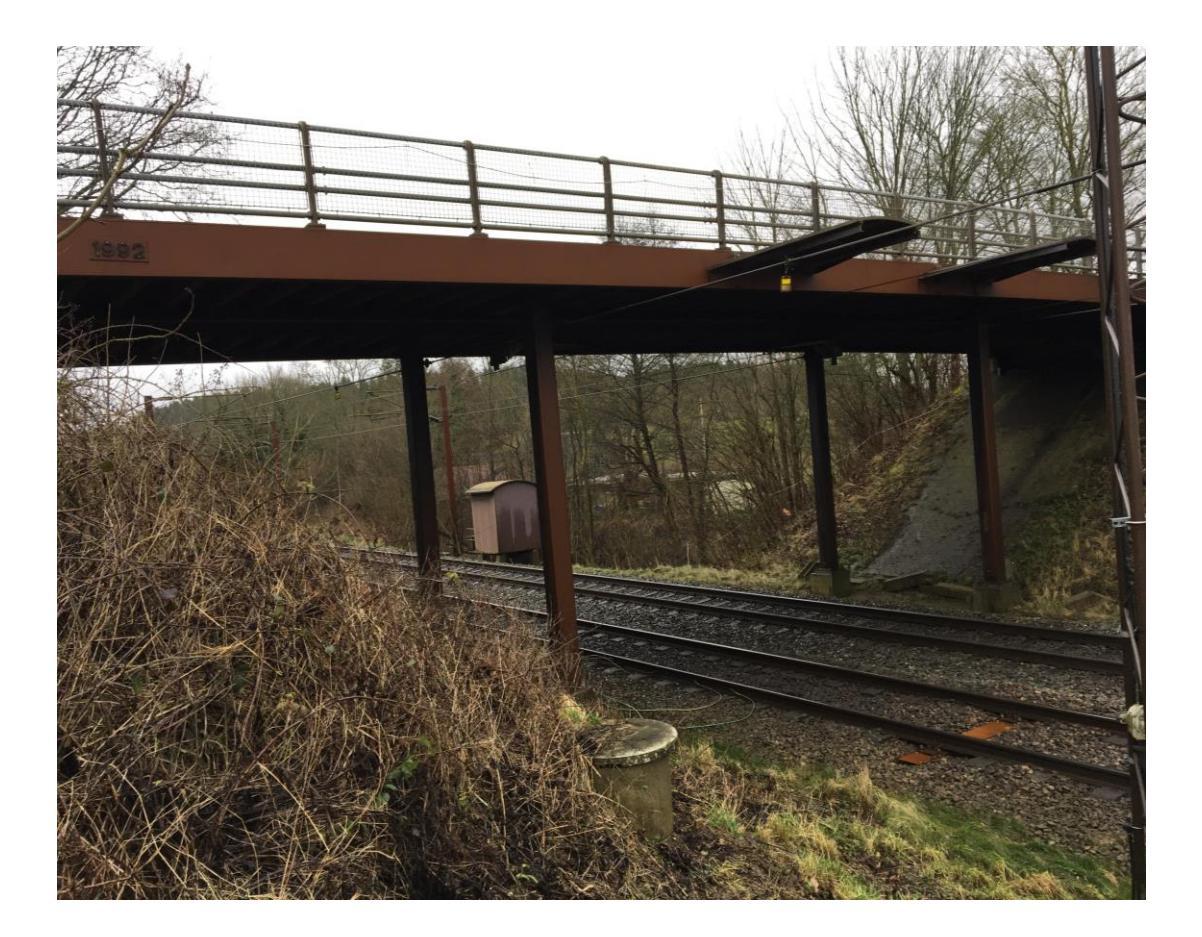
- Bridges made from COR-TEN
- Welded sections not as many details
- 25 years of exposure

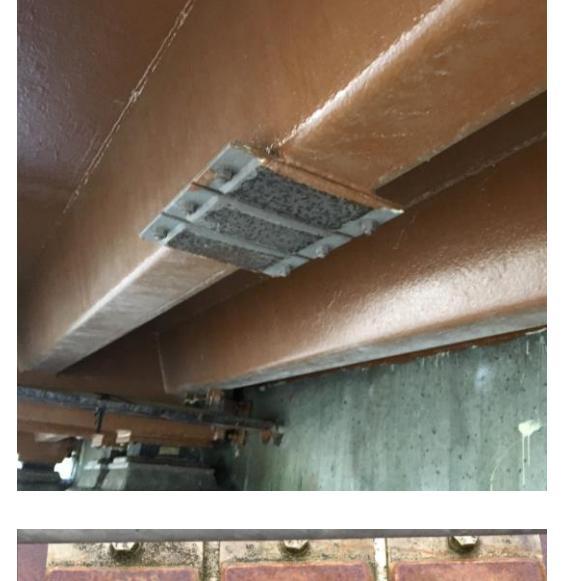
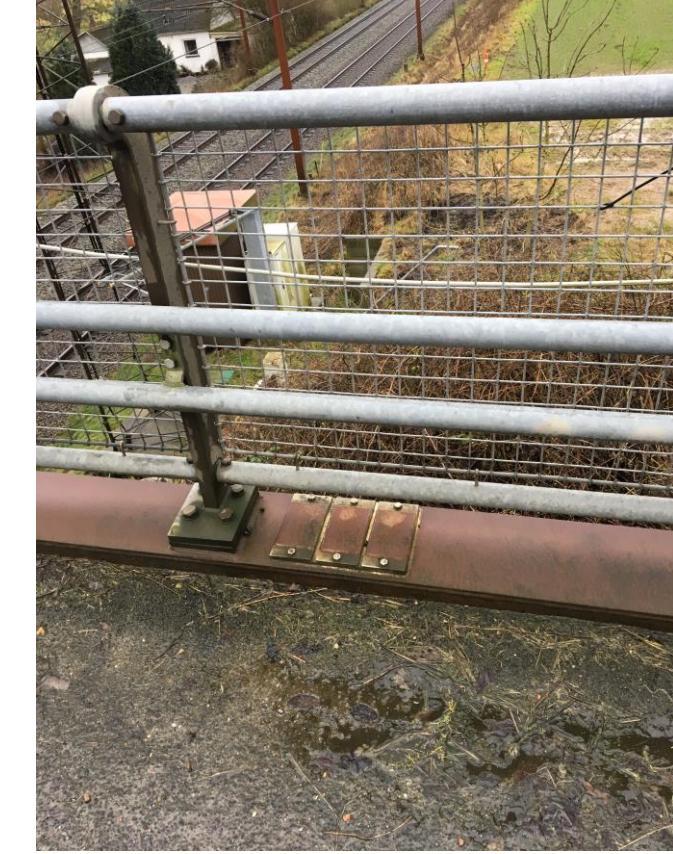
- Test regime similar to masts
- Test plates measured at intervals
 - Top of bridge
 - Soffit of bridge (abutment)
 - Soffit of bridge (railway tracks)

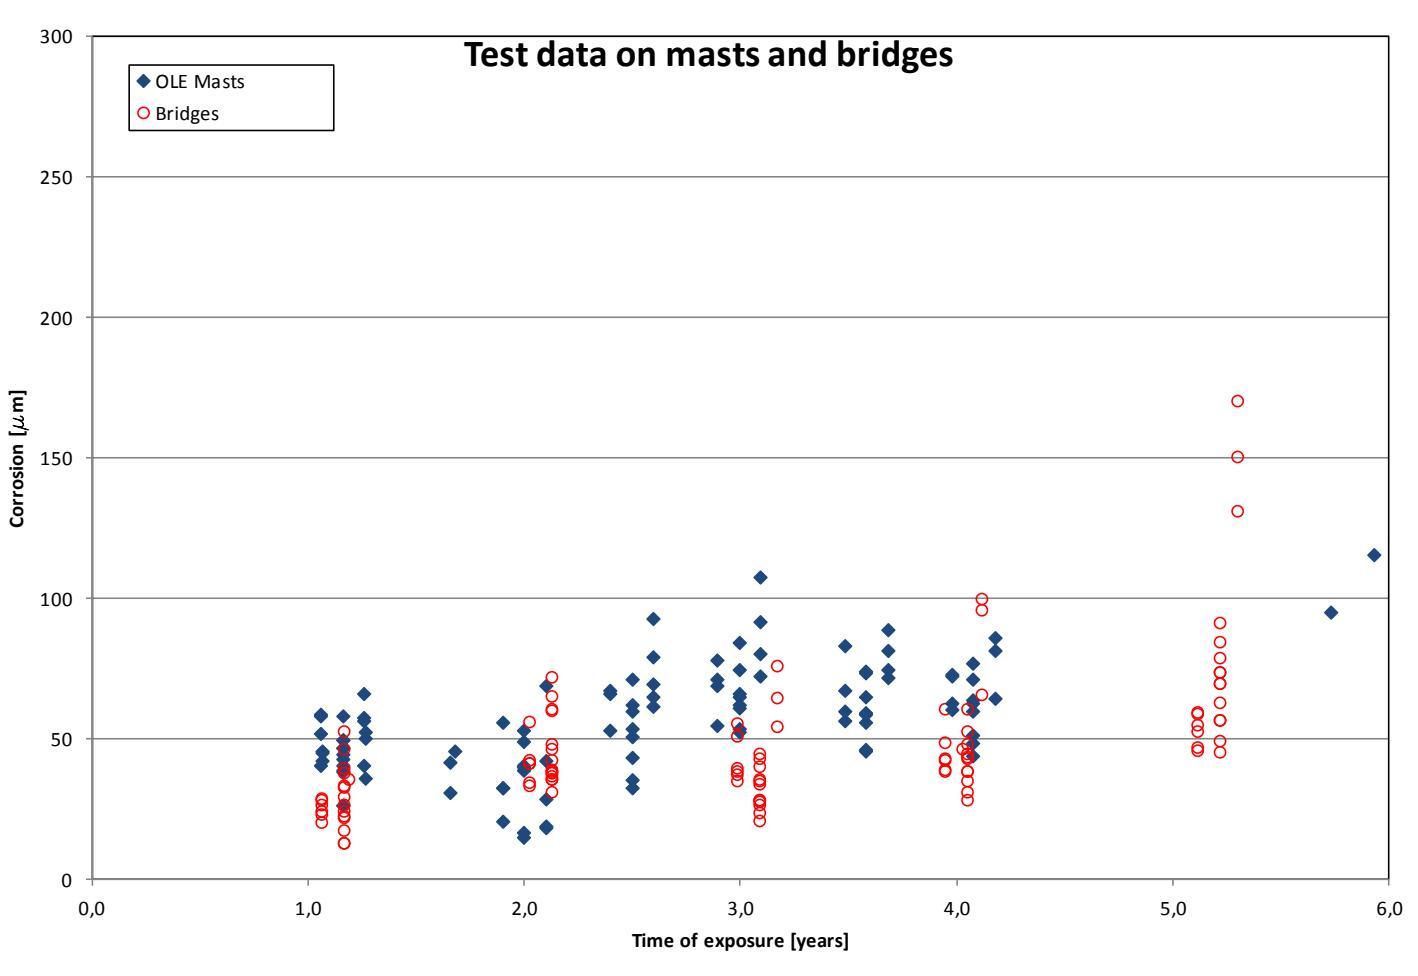
- Tendency on orientation not as clear as on masts
- Clearly faster corrosion above railway tracks (diesel engines?)
- In general a tendency to faster corrosion on bridges
